SIBLING  
ARCHITECTURE

OLD BEGA HOSPITAL  
ARTS & CULTURAL CENTRE

CONCEPT DESIGN REVIEW 06  
26.02.2018

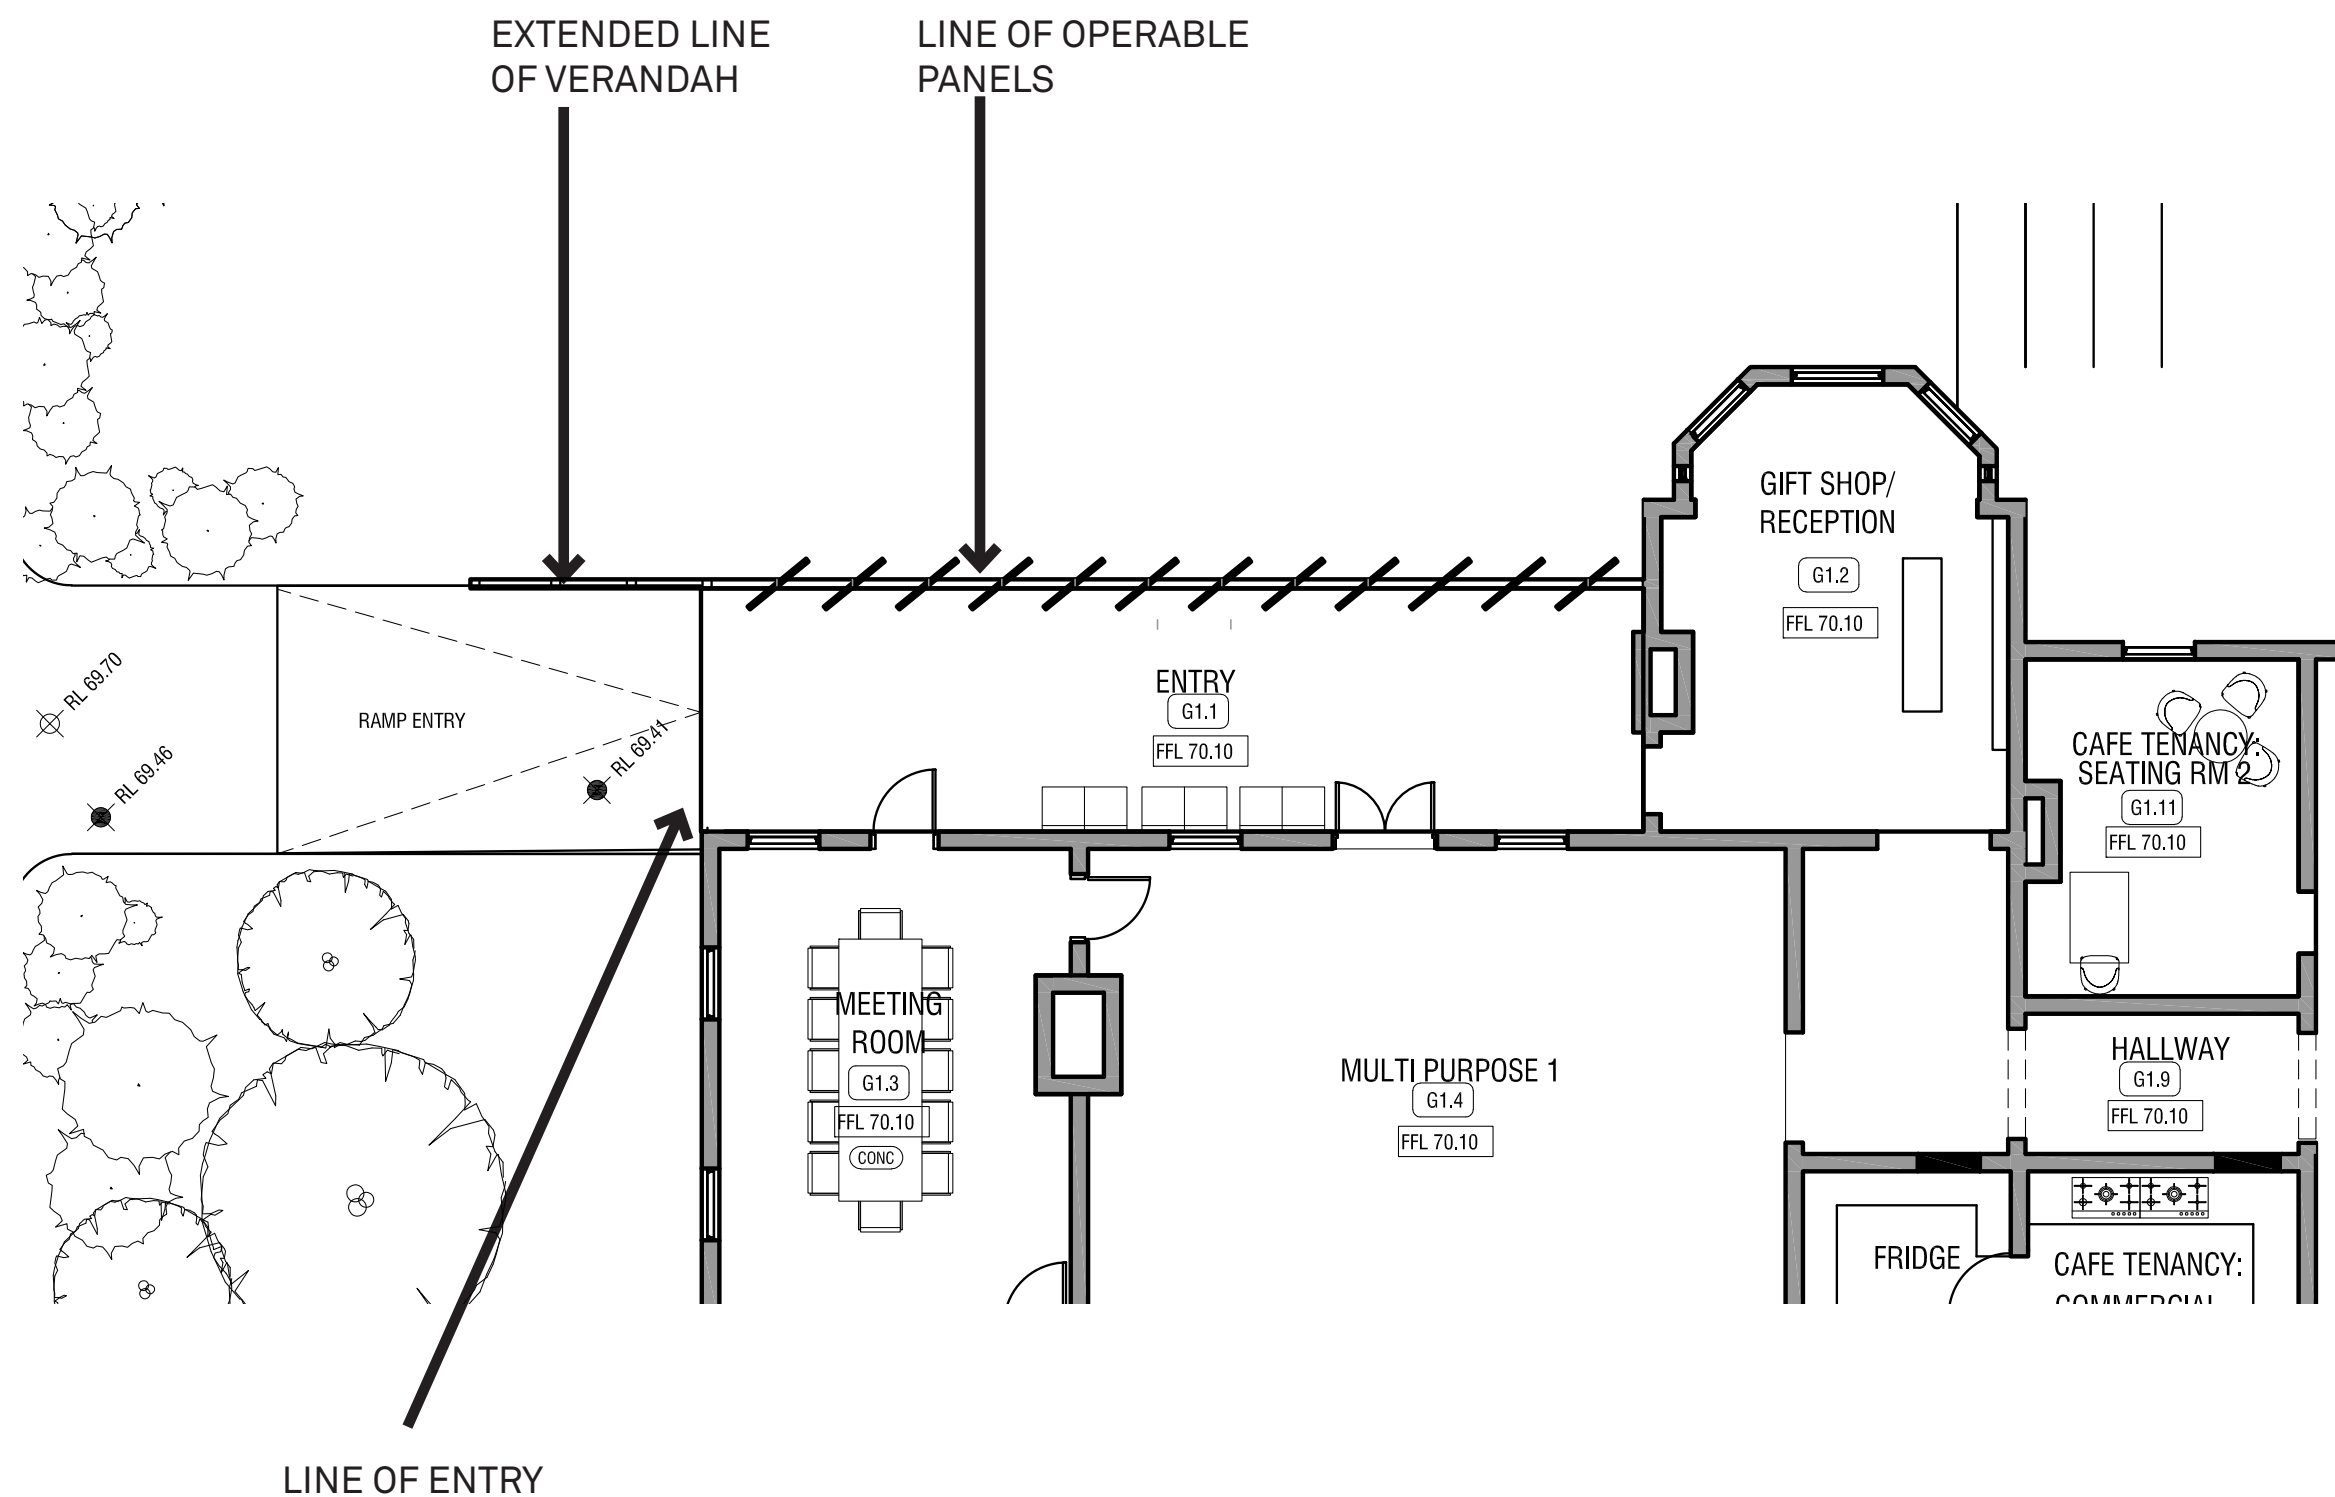
PREVIOUS PLAN SHOWING NORTH WEST ENTRY

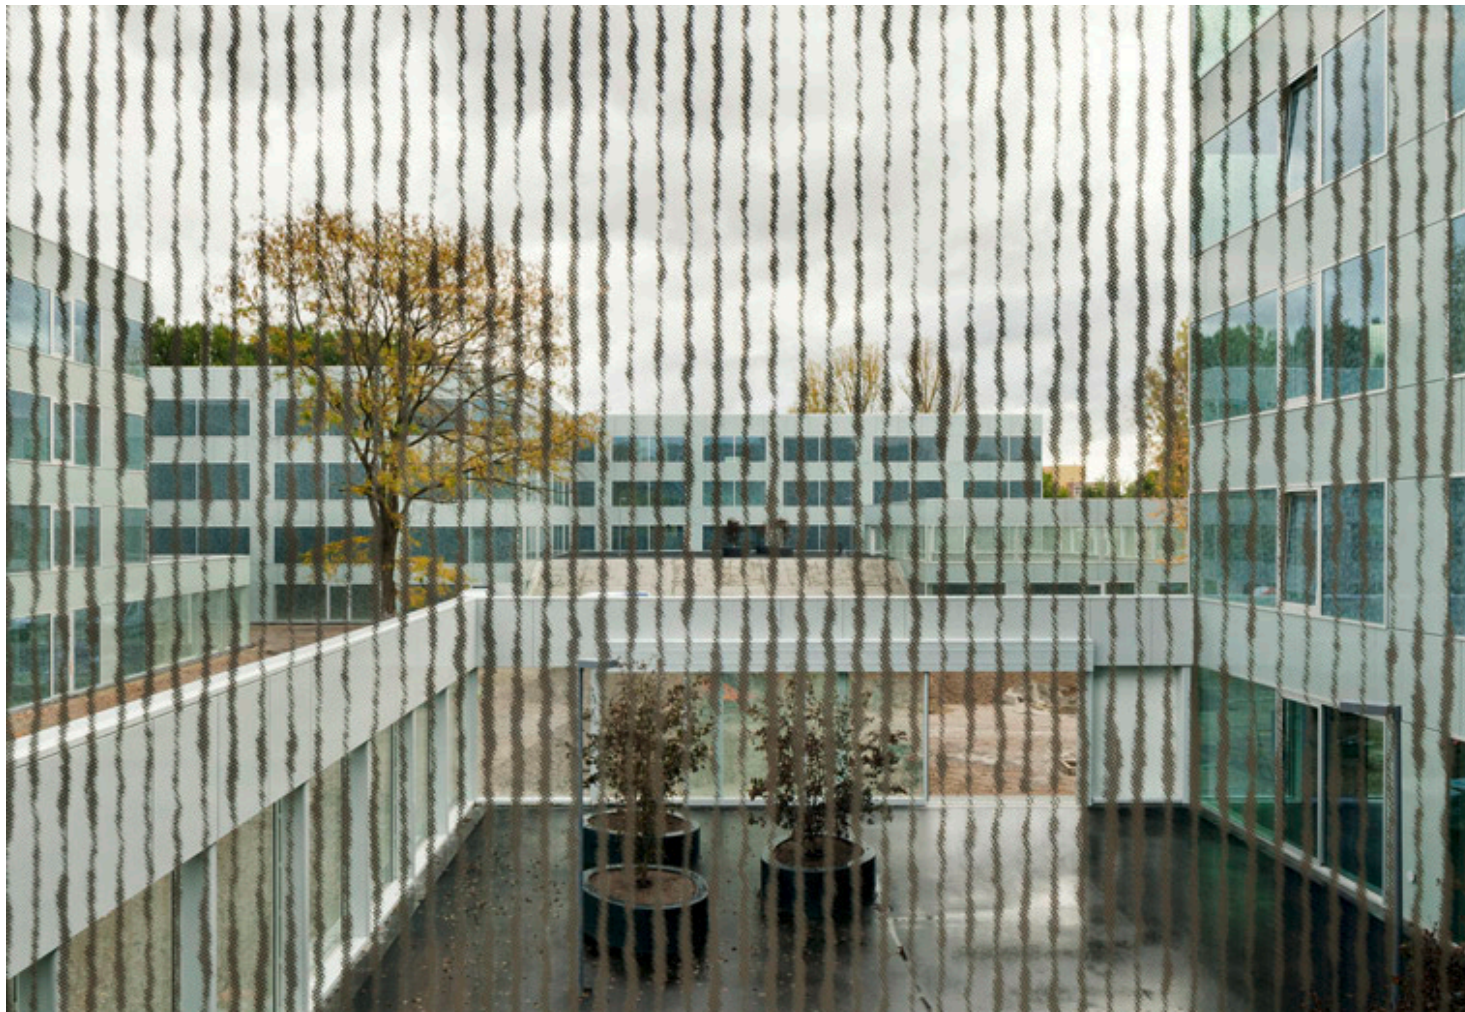
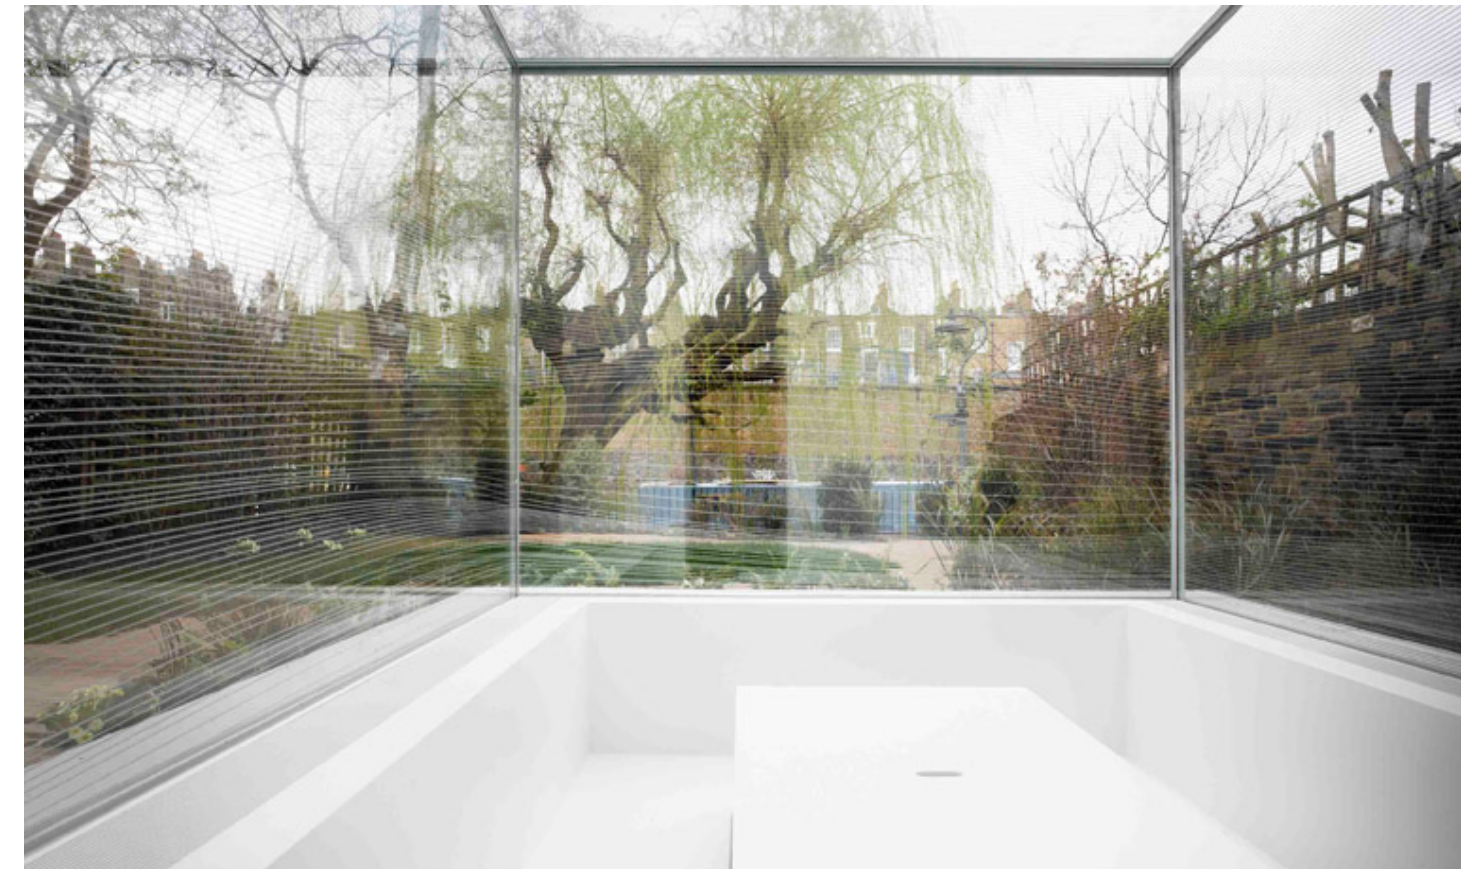
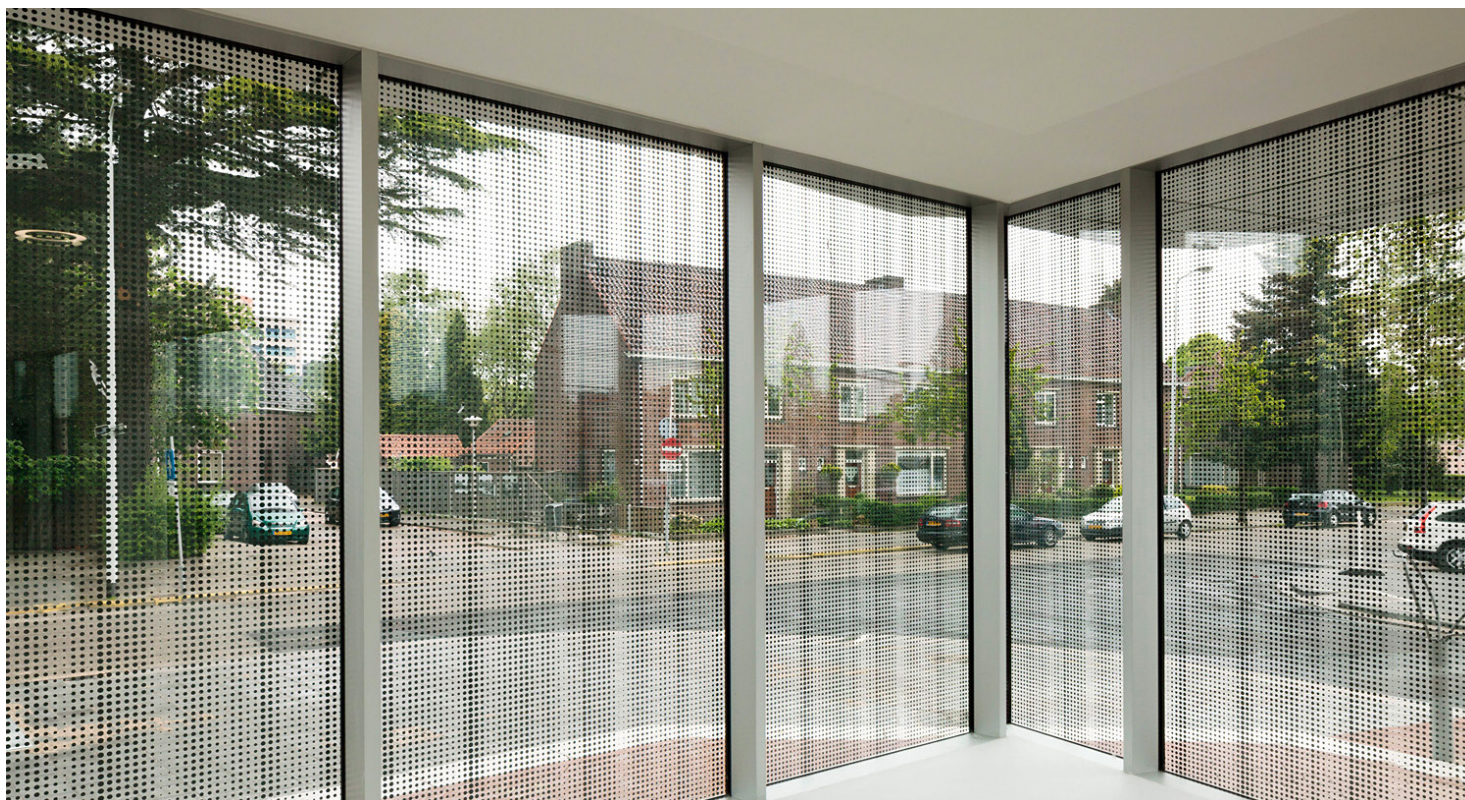
## GRAPHIC FILM GLAZING PRECEDENCES

COLUMNS AND PATTERNS  
APPLIED TO GLAZING WITH FRITT

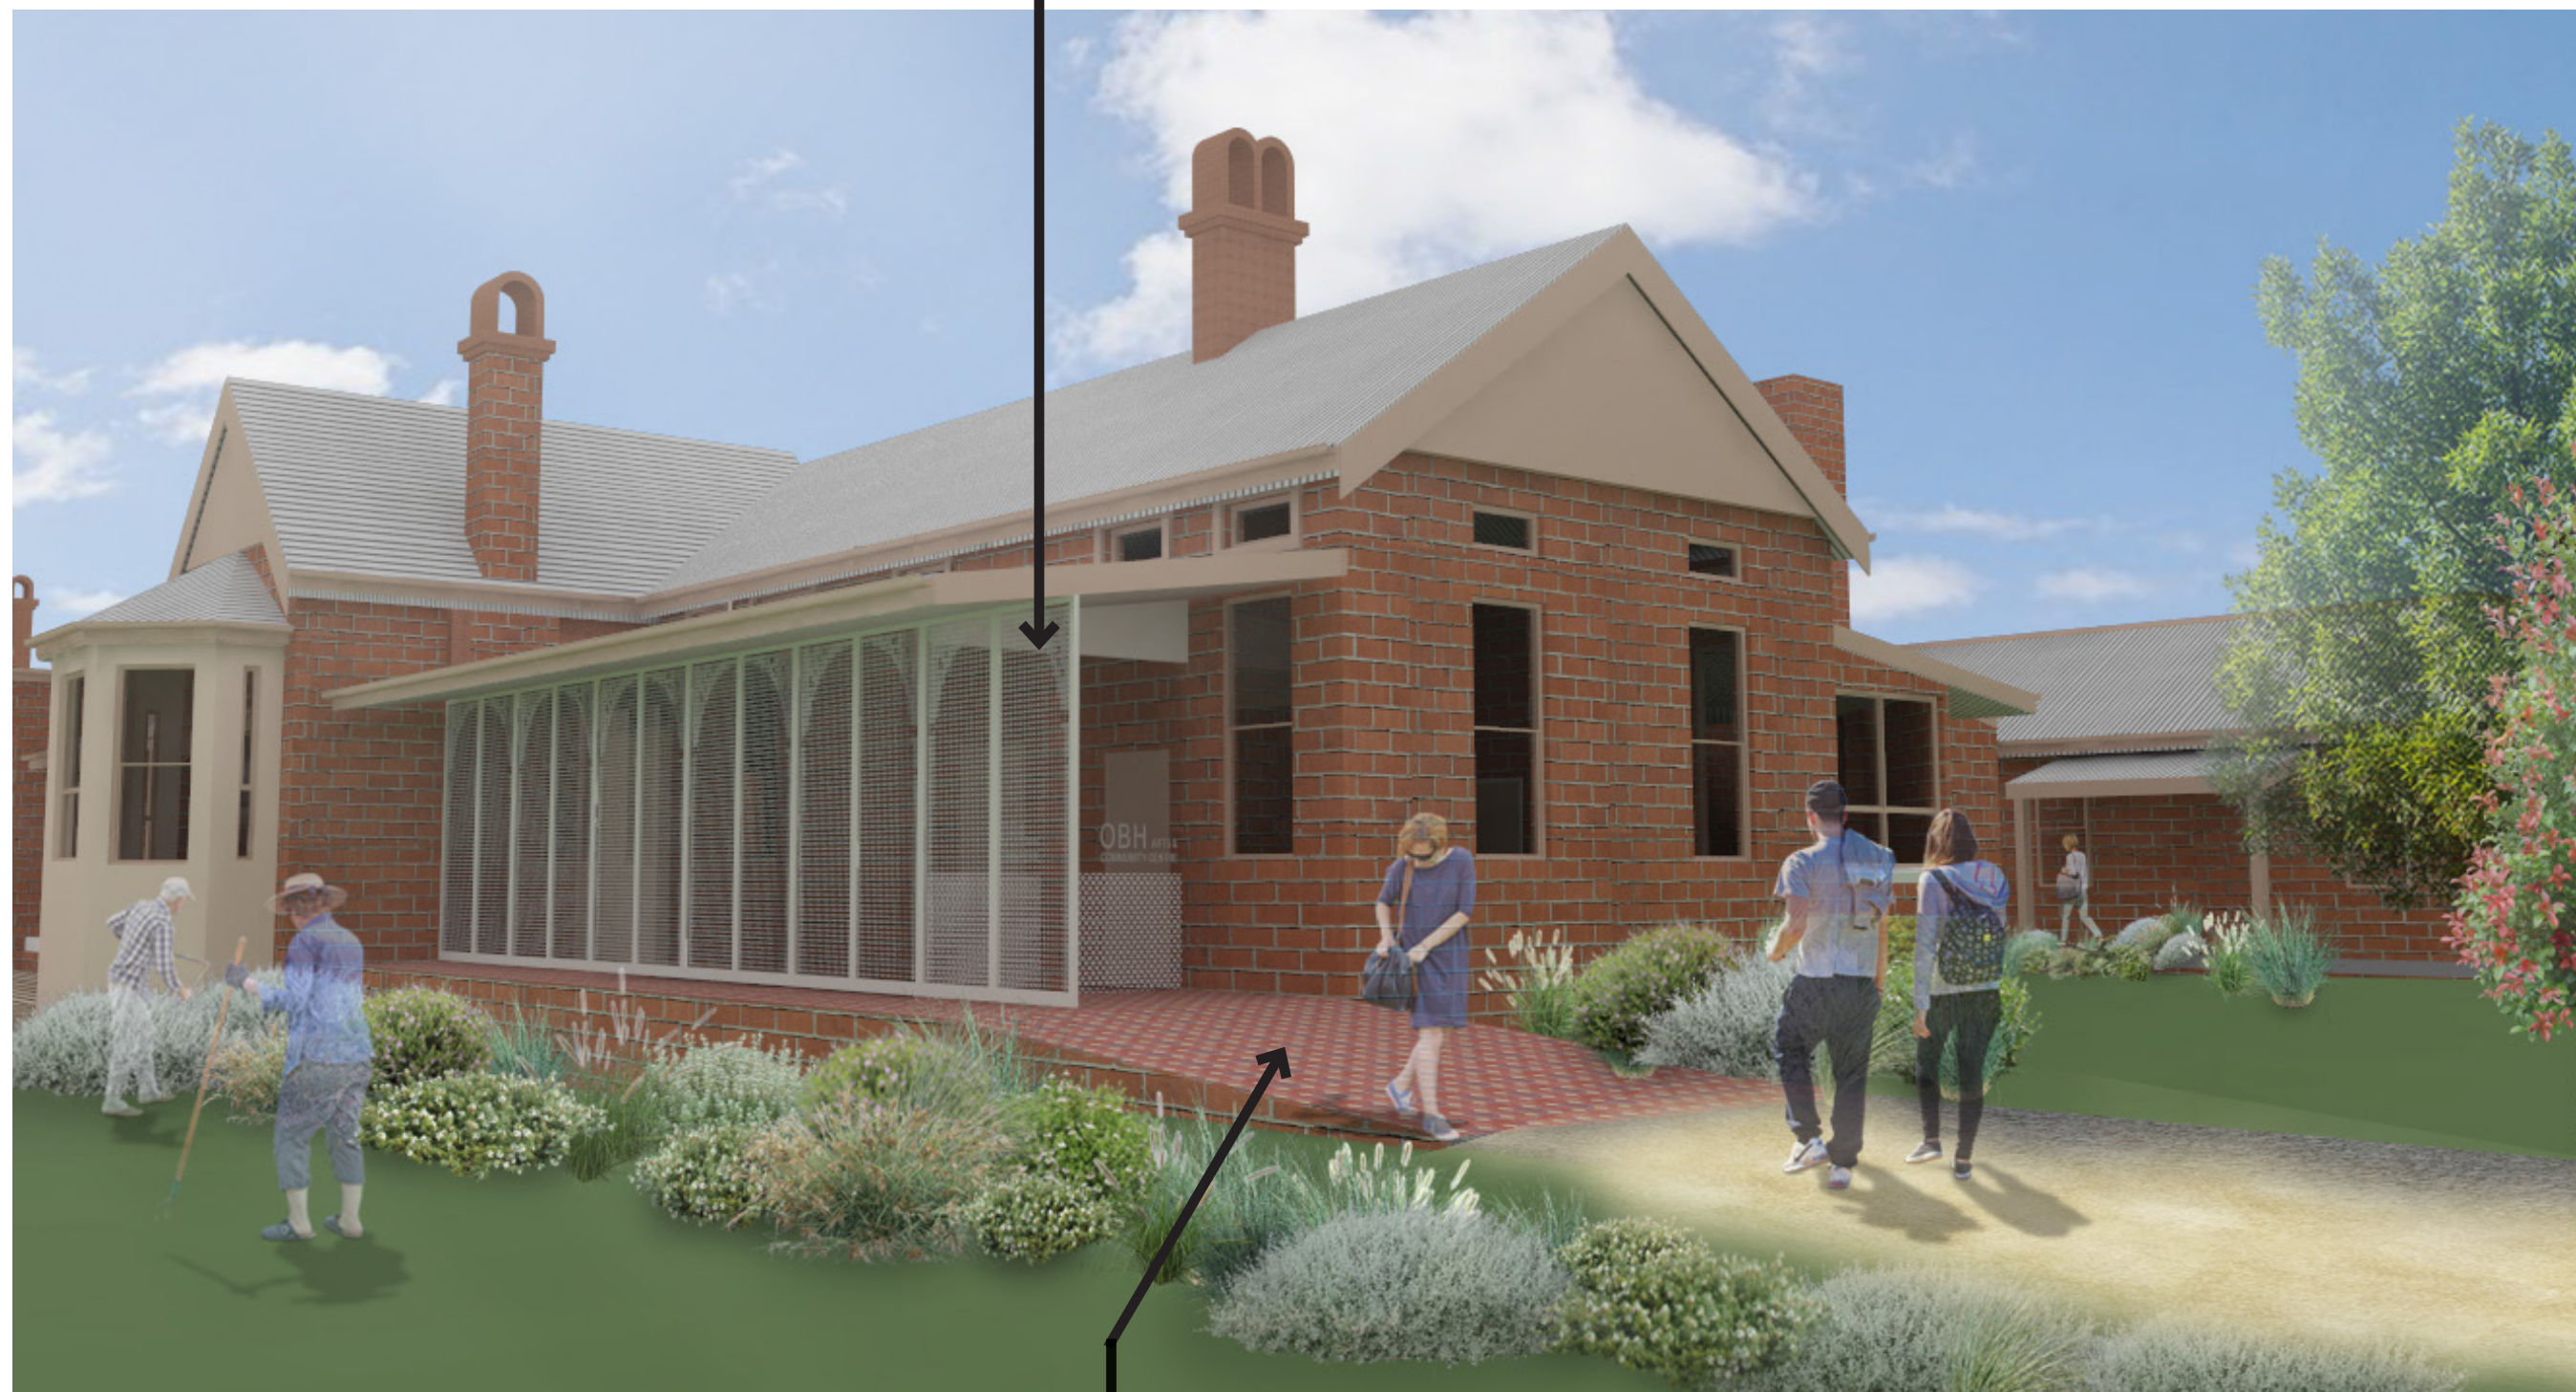
TILING TO ENTRY

UPDATED NORTH WEST ENTRY VERANDAH VIEW-CLOSED

COLUMNS AND PATTERNS  
APPLIED TO GLAZING WITH FRITT

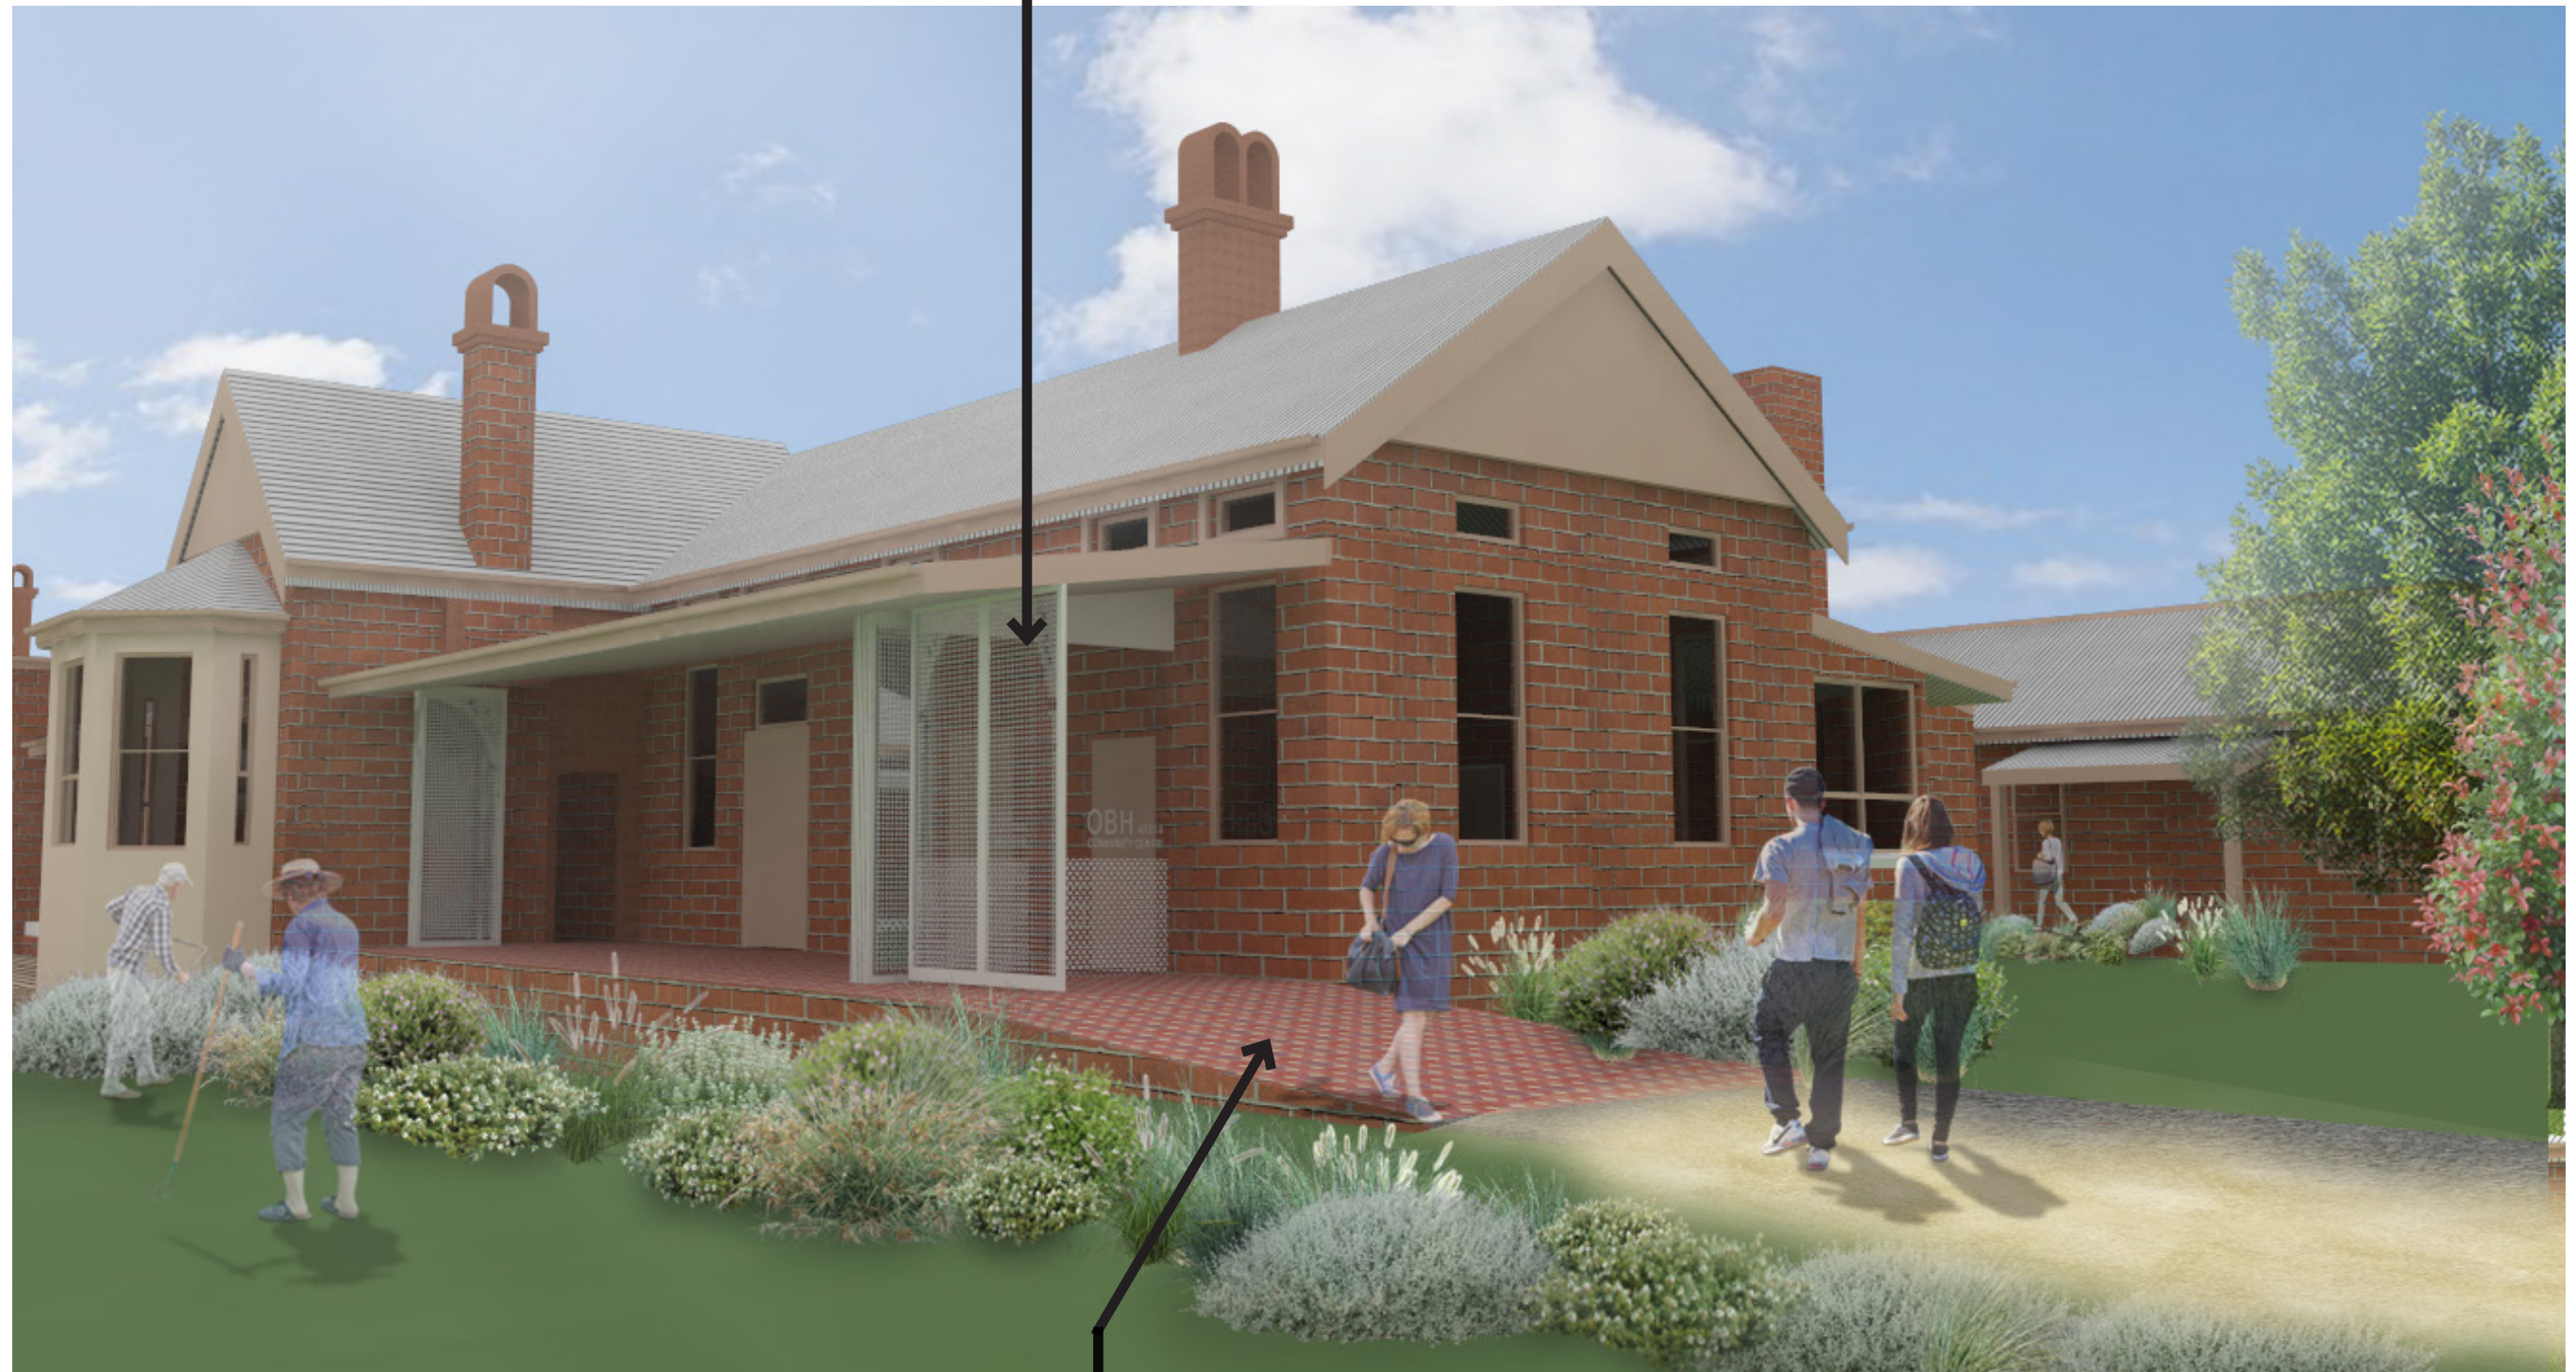
TILING TO ENTRY

UPDATED NORTH WEST ENTRY VERANDAH VIEW-OPEN

COLUMNS AND PATTERNS  
APPLIED TO GLAZING WITH FRITT

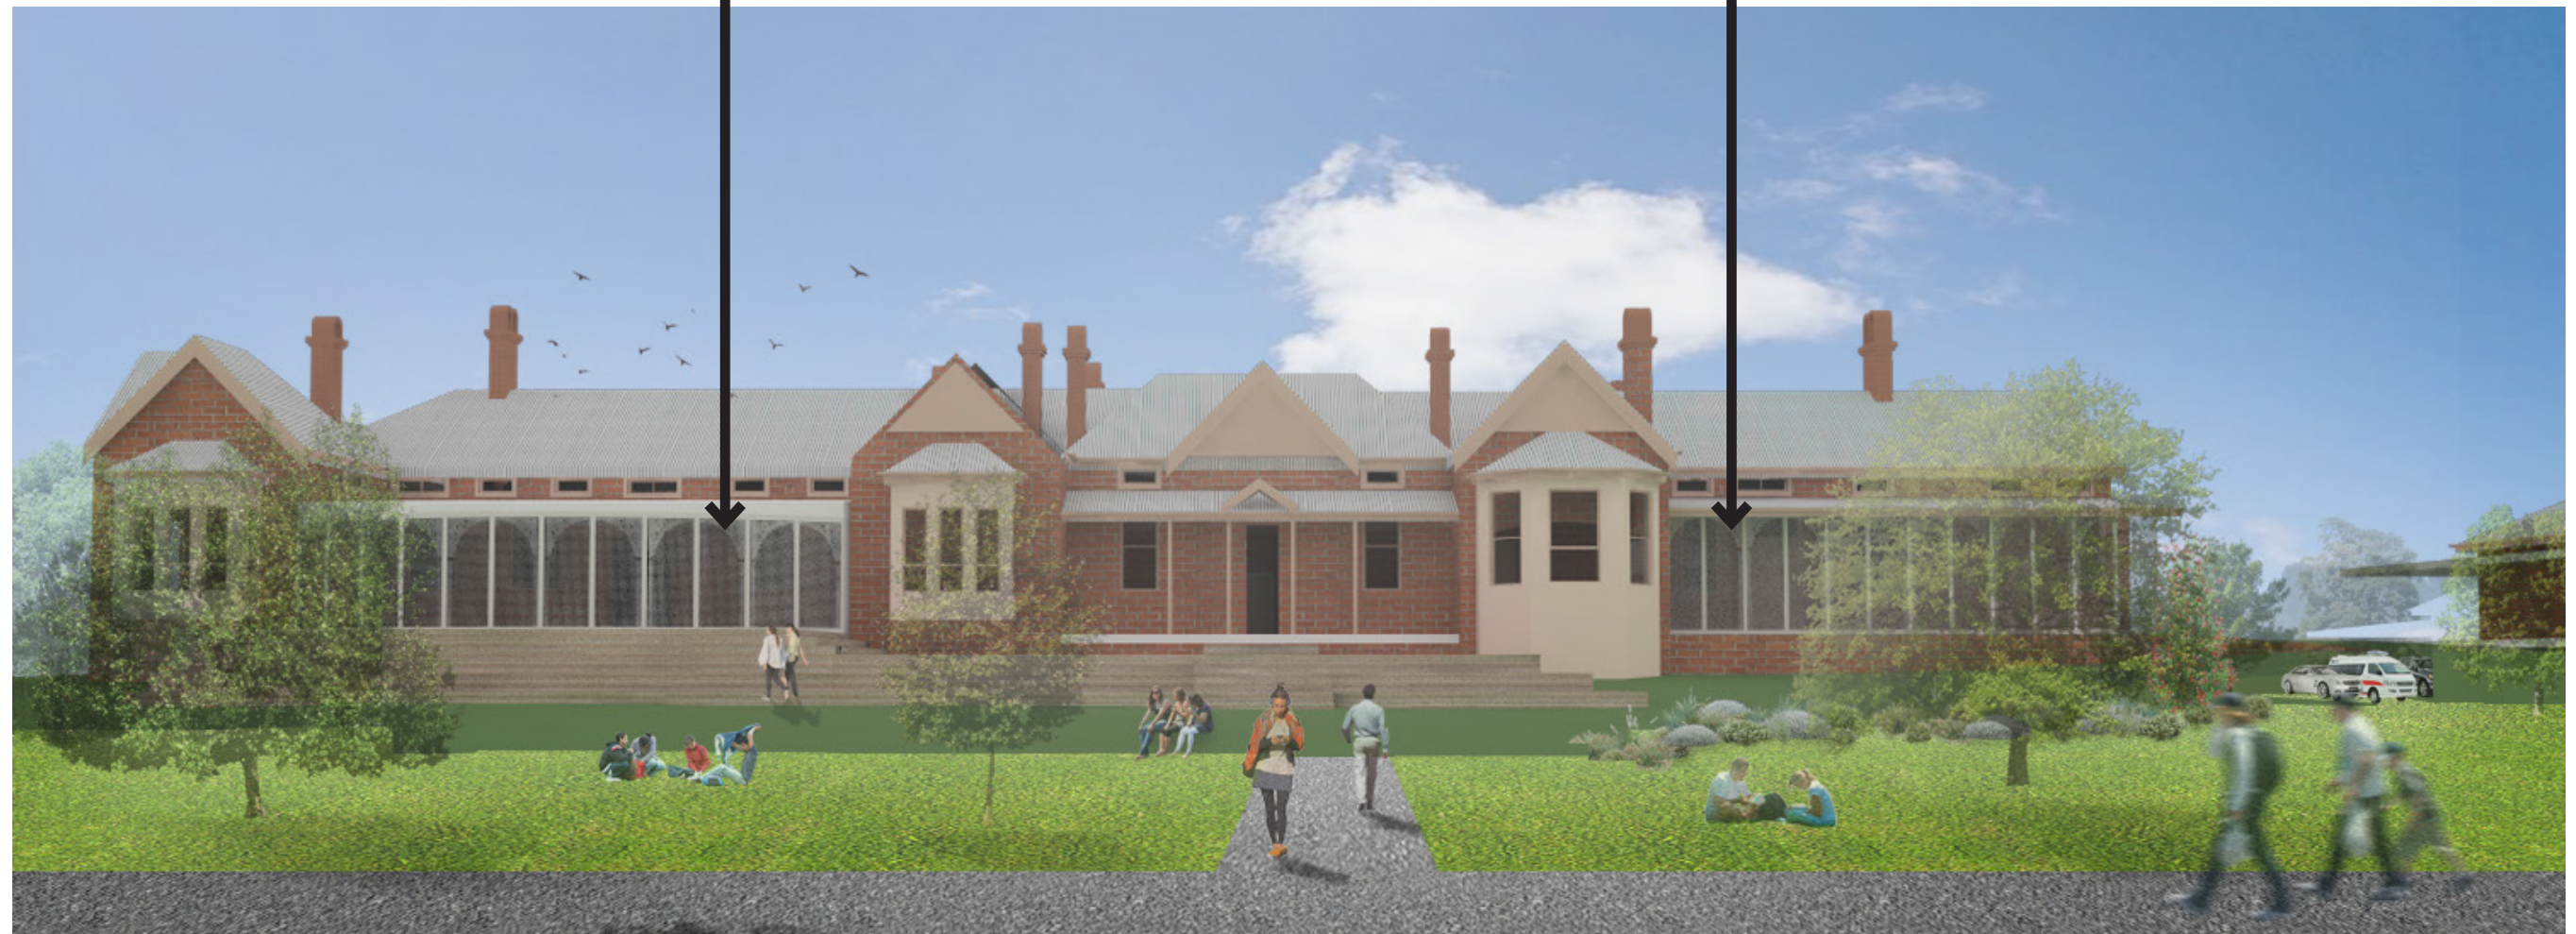
UPDATED FRONT VIEW-CLOSED

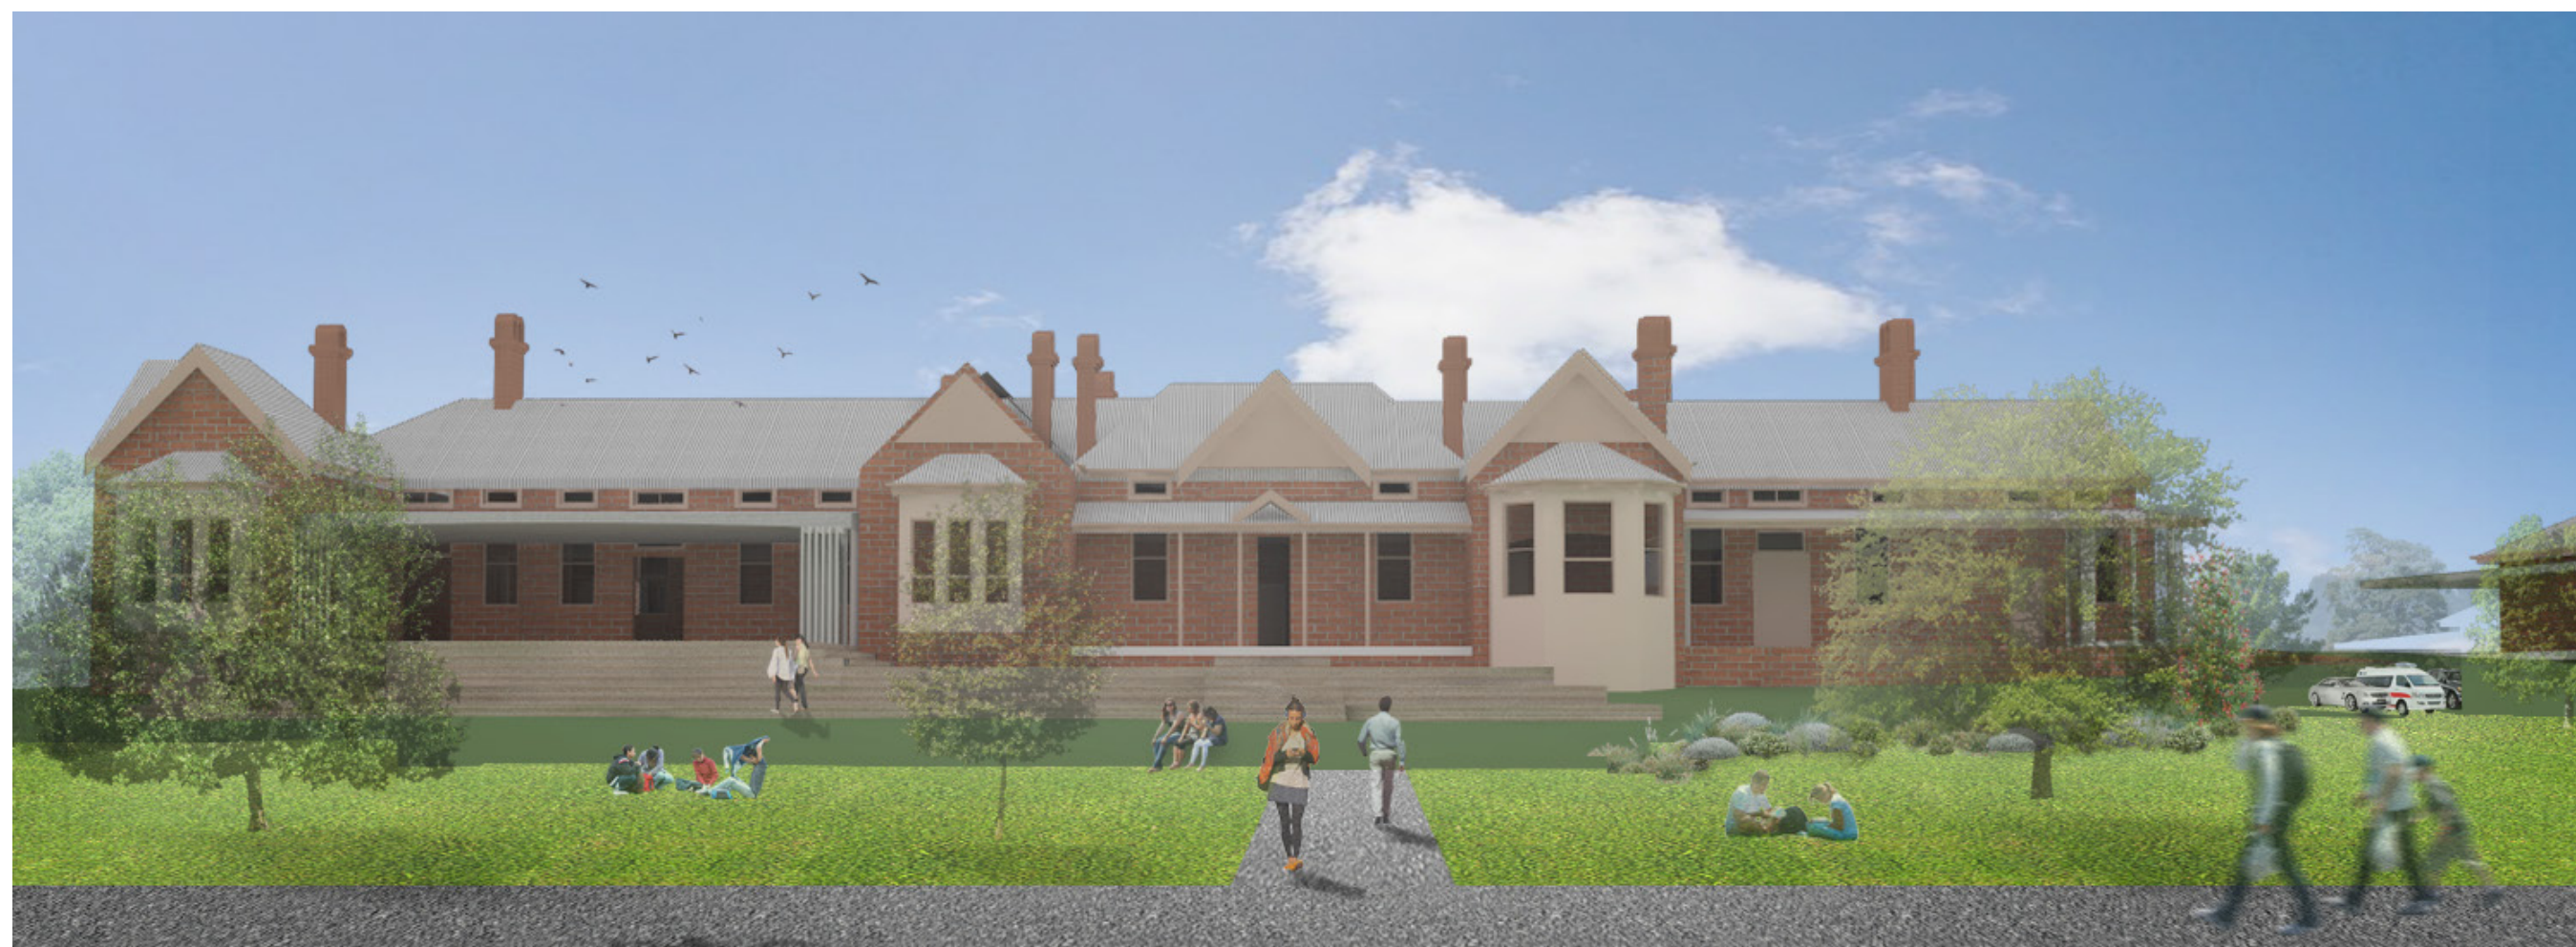
**UPDATED FRONT VIEW-OPEN**

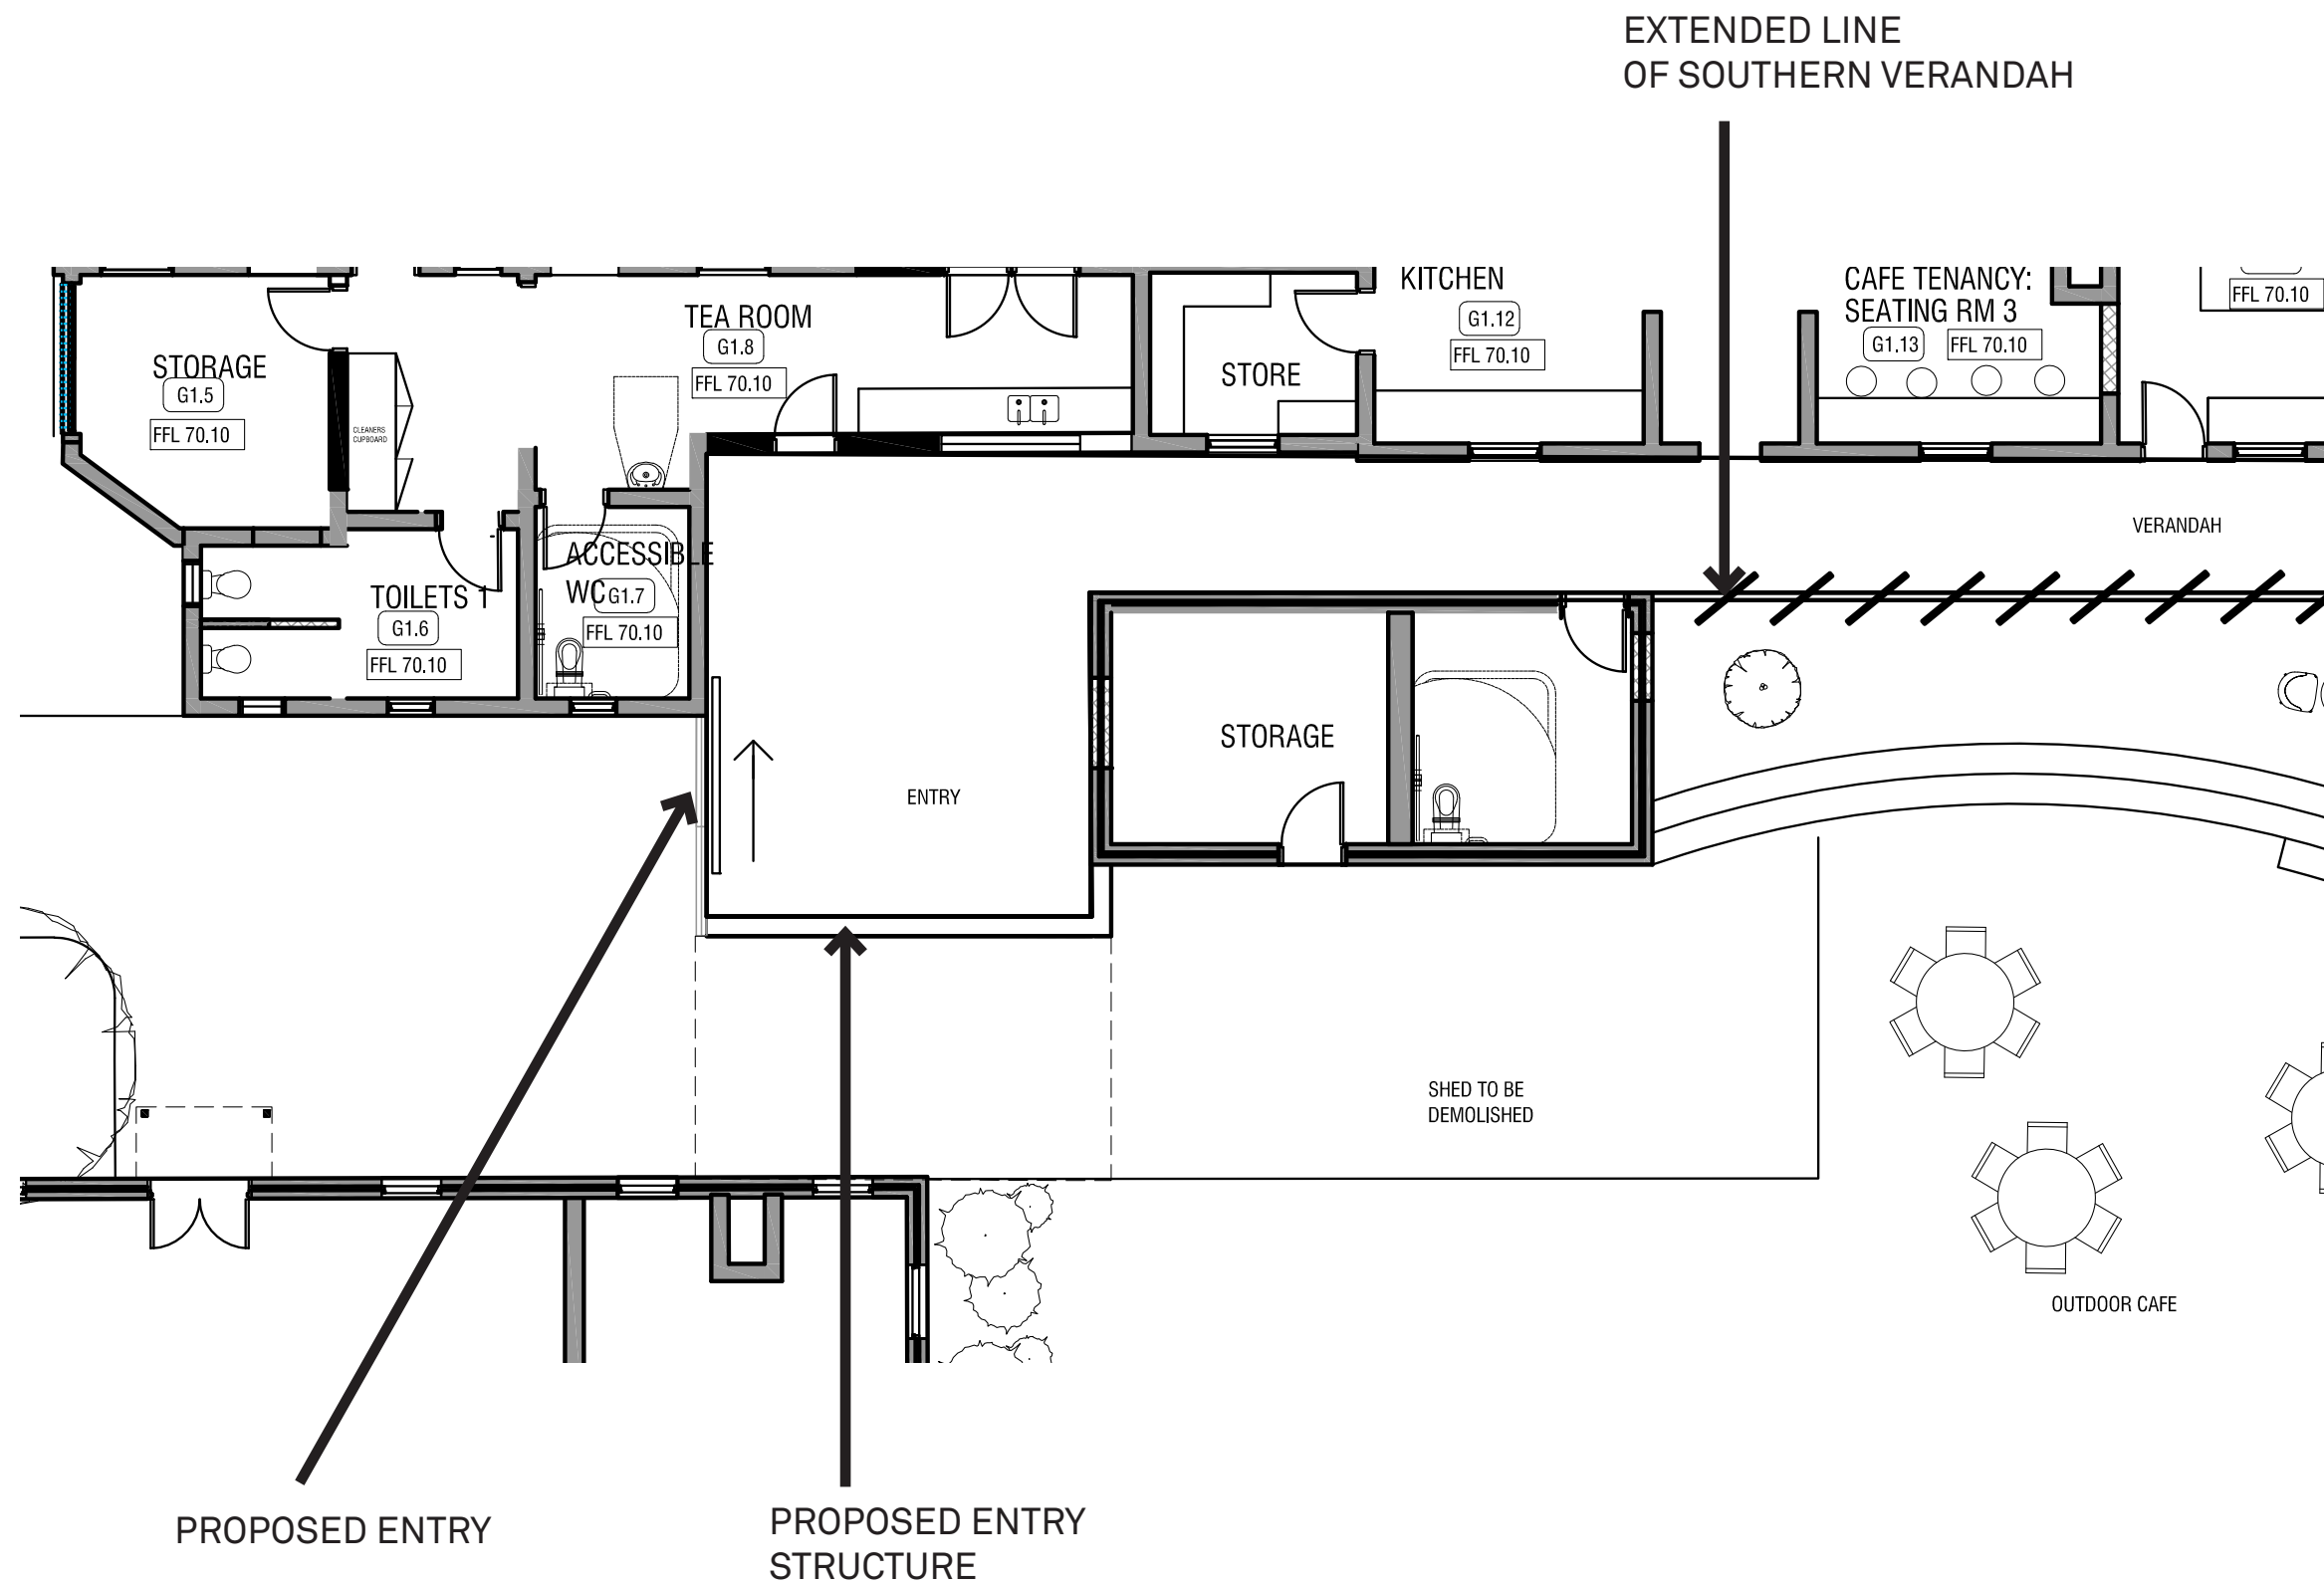
**PREVIOUS PLAN SHOWING SOUTHERN ENTRY**
