SIBLING  
ARCHITECTURE

OLD BEGA HOSPITAL  
ARTS & CULTURAL CENTRE

CONCEPT DESIGN REVIEW 06  
26.02.2018

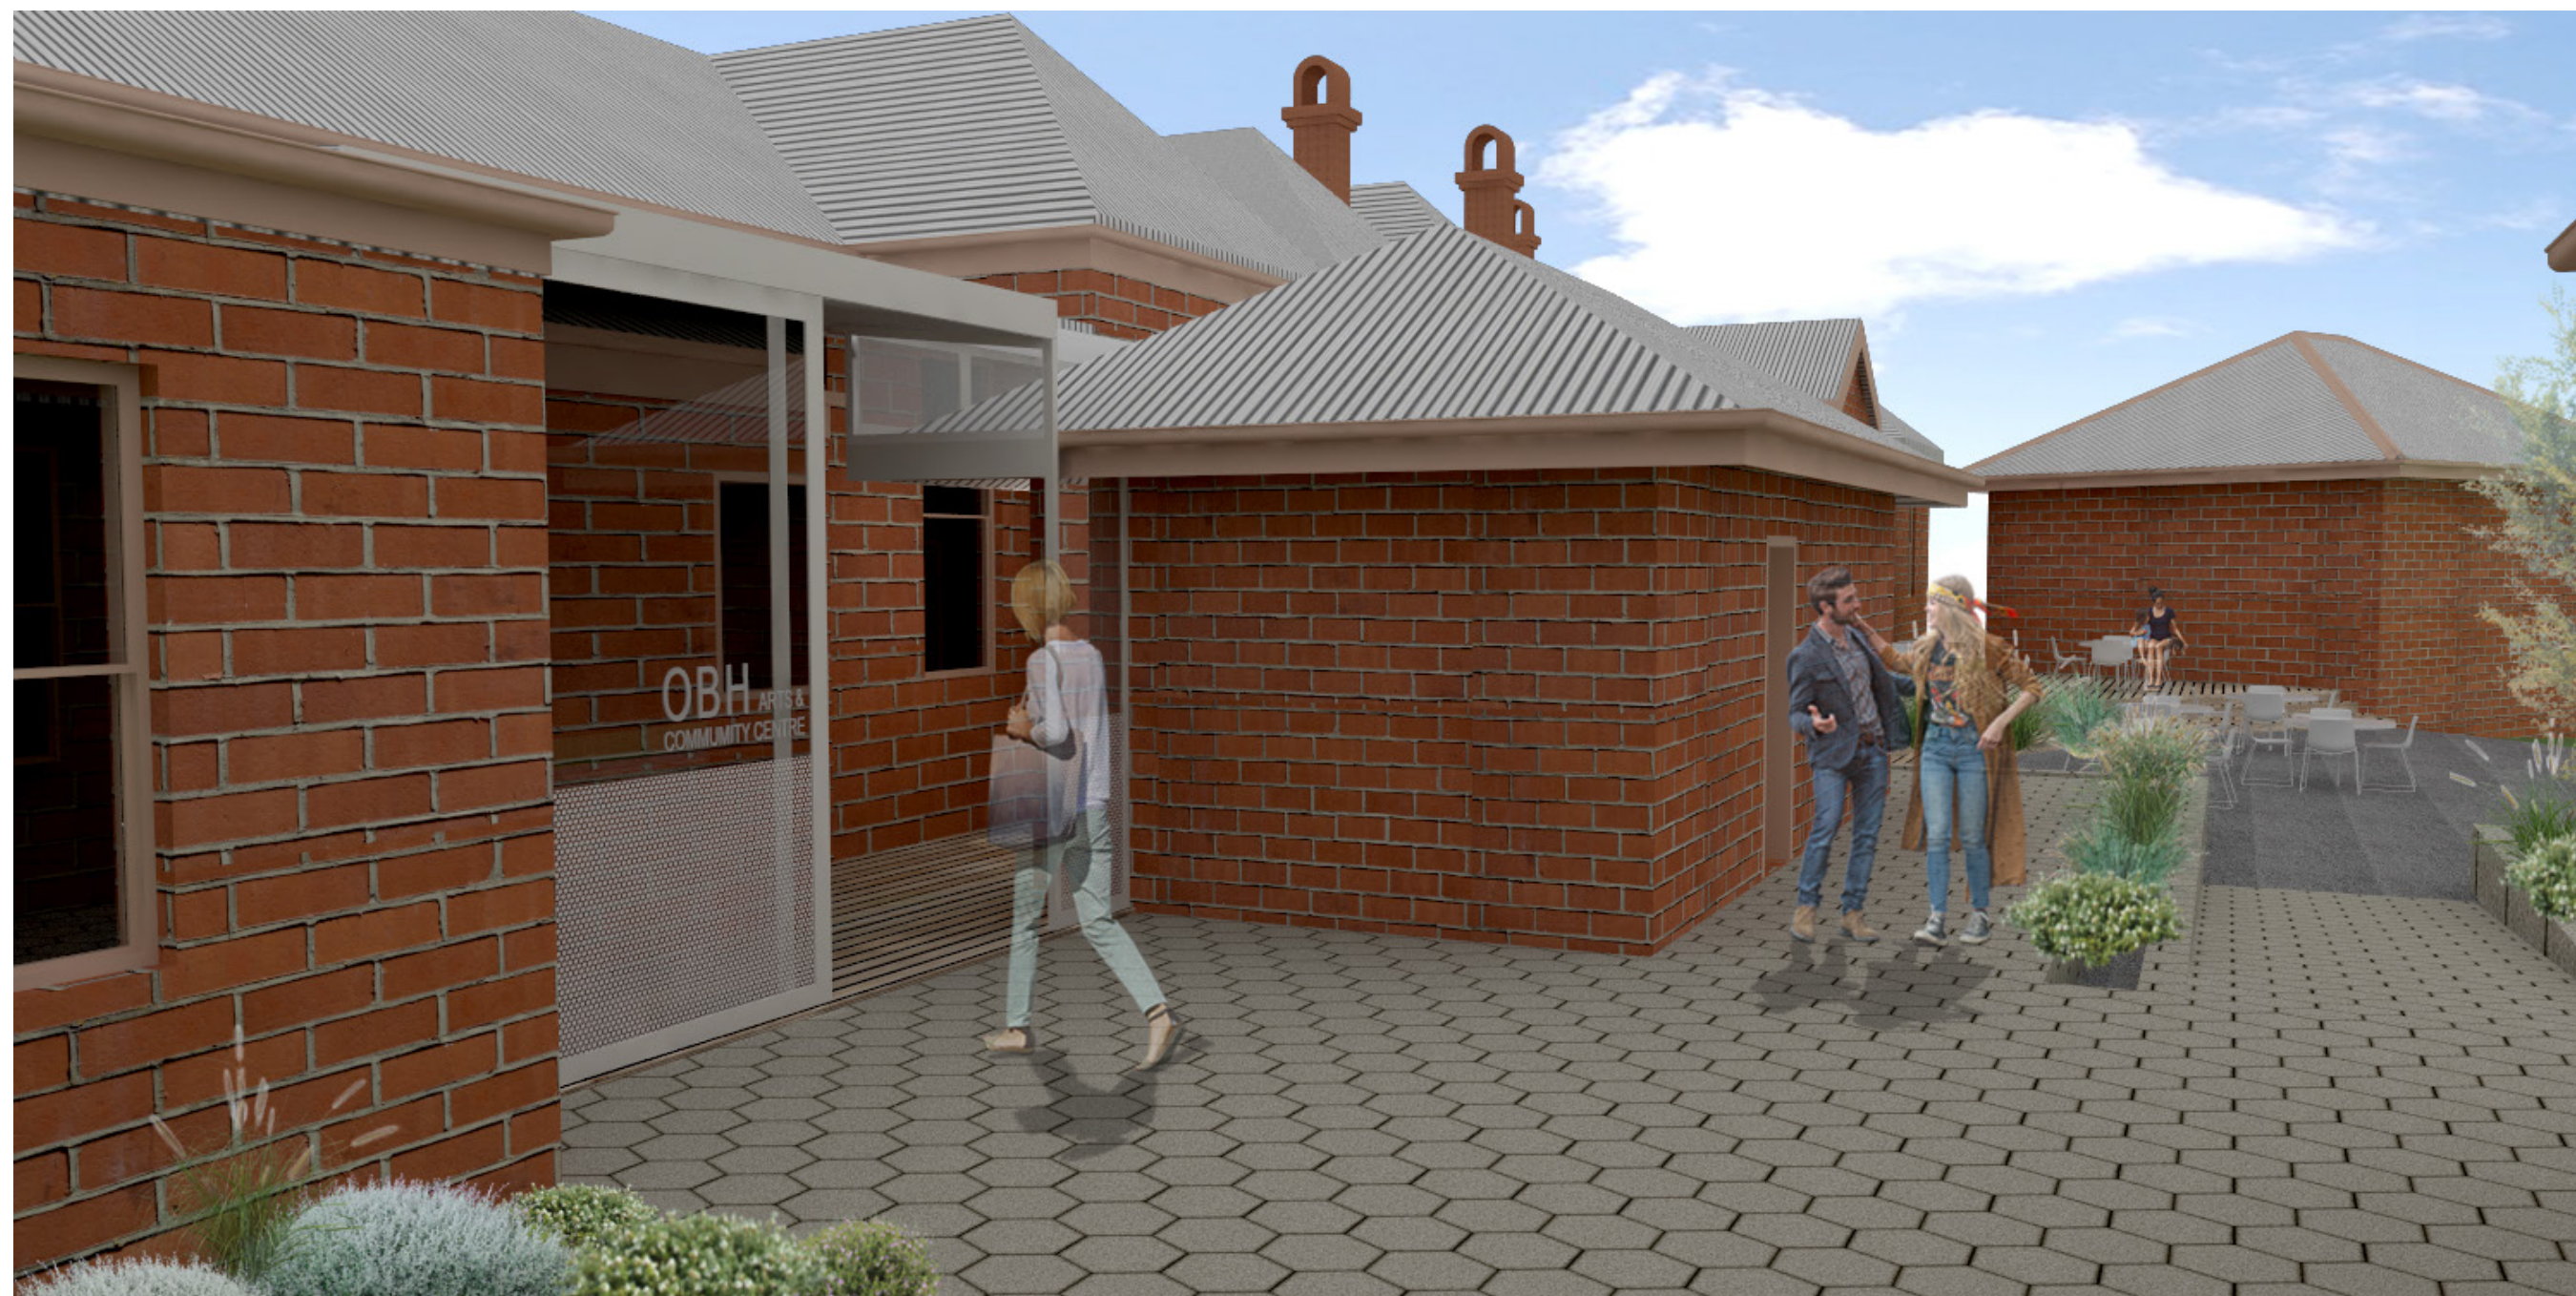
UPDATED SOUTHERN ENTRY (WEST OF MORGUE)- OPEN

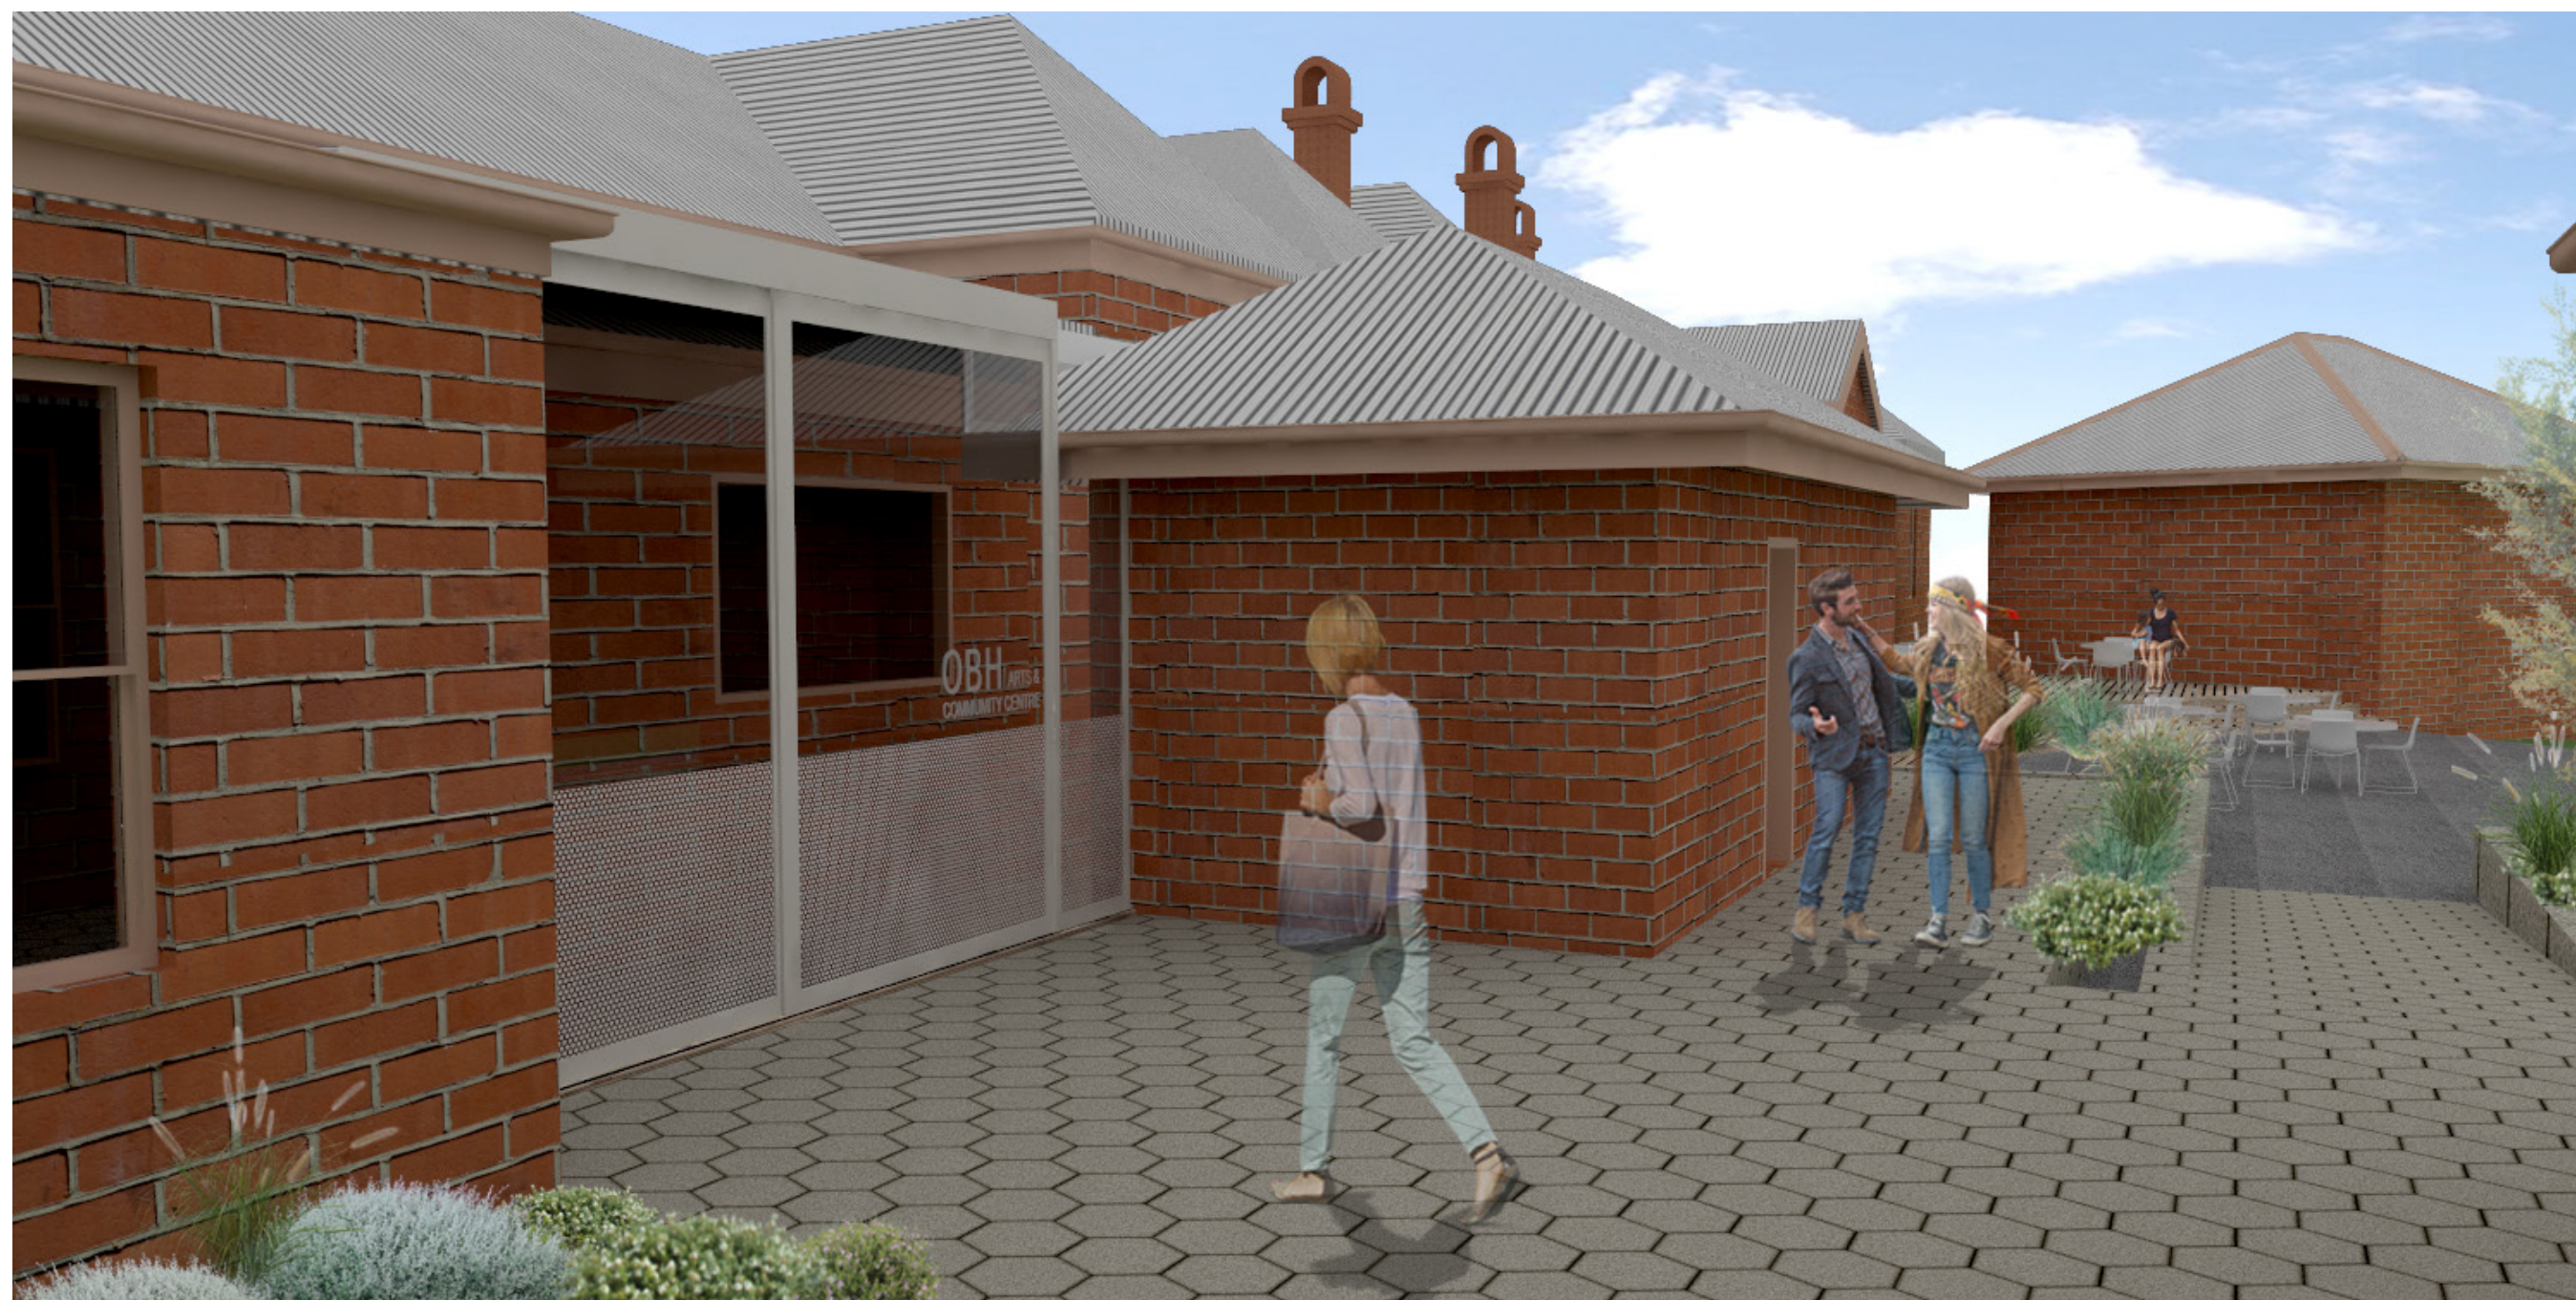
**UPDATED SOUTHERN ENTRY (WEST OF MORGUE)- CLOSED**

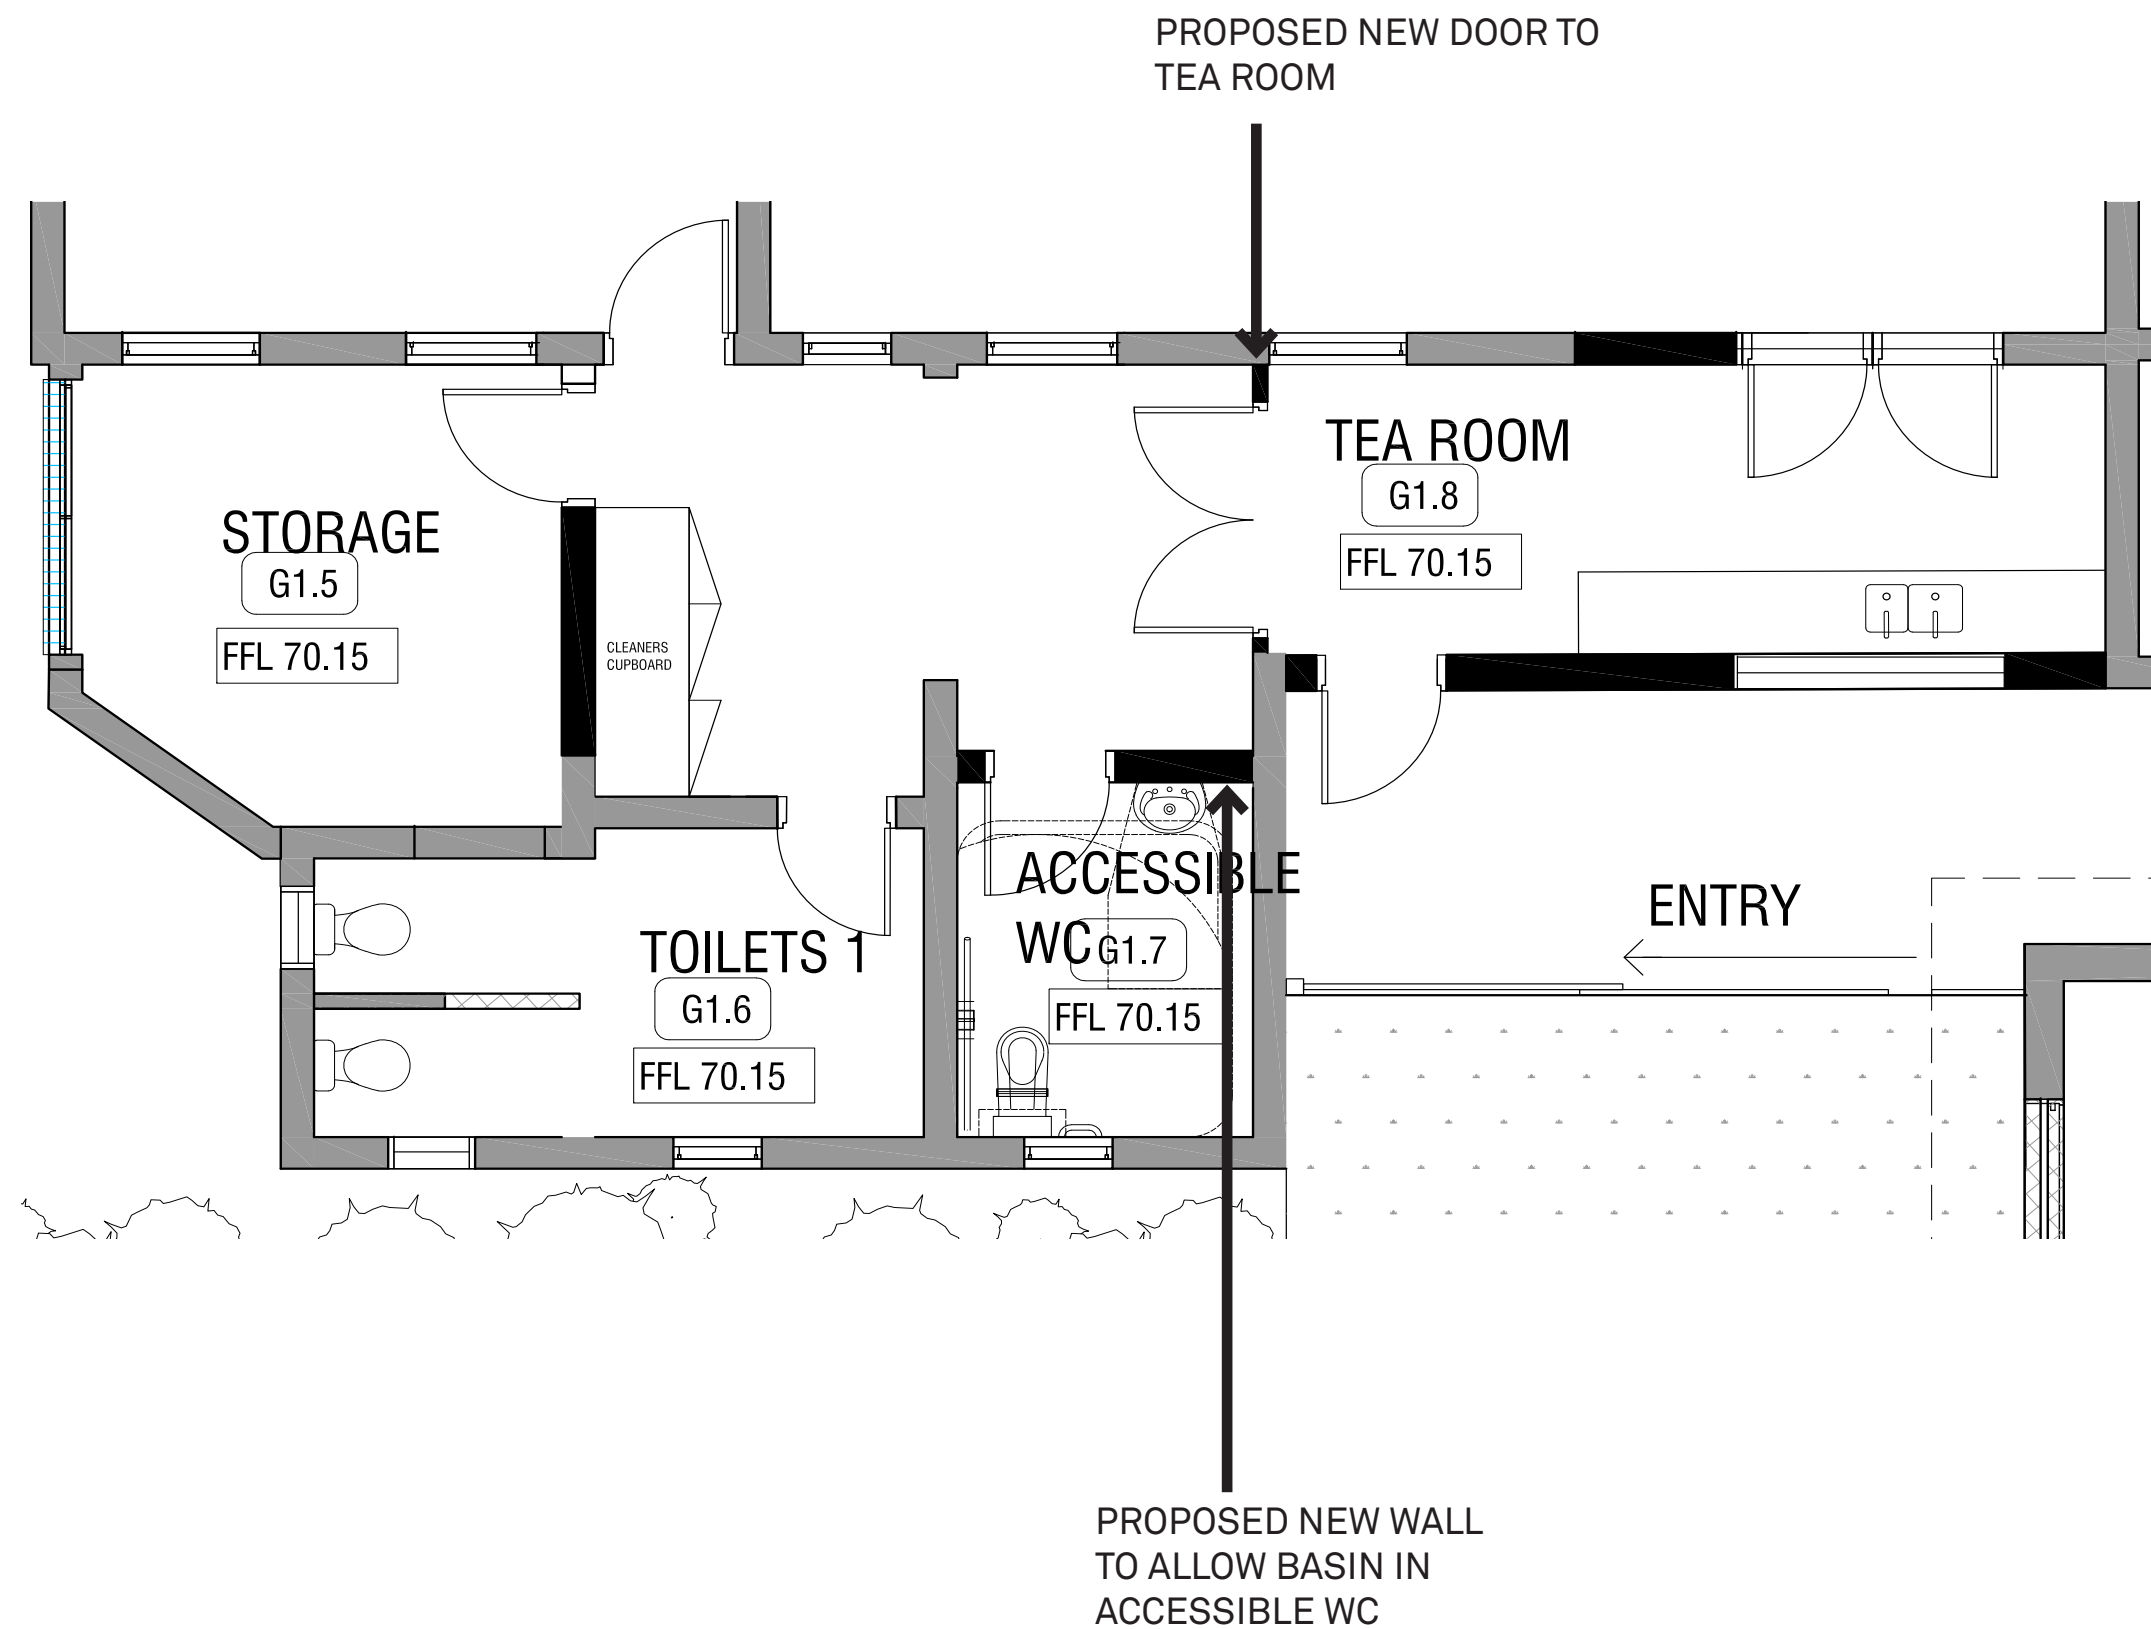
- 1) MOVE EXISTING DISABLED TOILET NORTH TO ALLOW BASIN INSIDE
- 2) SEPARATE ENTRY TO DISABLED TOILET FROM TEAROOM

**PLAN SHOWING CHANGES TEA ROOM**
