STATEMENT OF ENVIRONMENTAL EFFECTS

APPLICATION SEEKING APPROVAL FOR RESTORATION

OF OLD BEGA HOSPITAL

Corkhill Place, Bega.

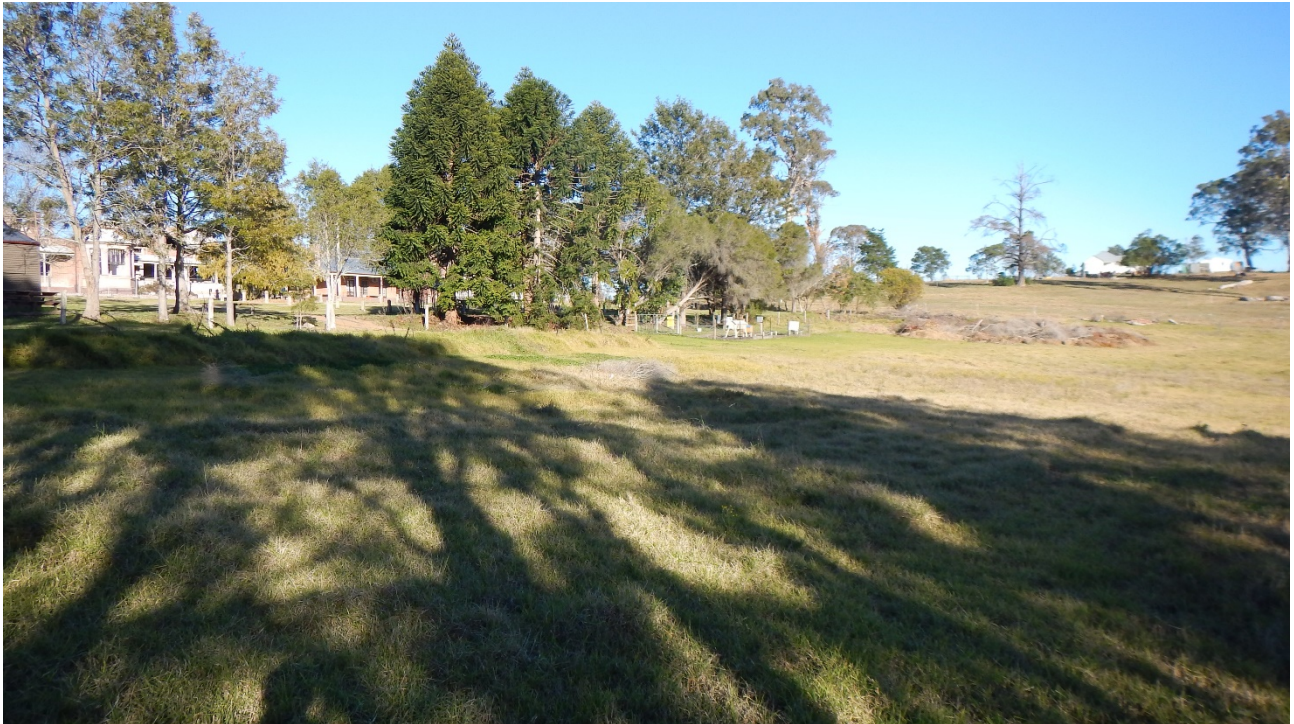
Figure 1 Most of the trees in the foreground would be removed to reinstate the vista from the building to Mumbulla mountain.

Approximately 12 trees/ shrubs as mapped on sheet 3 are proposed to be removed as part of the development. The value of these particular trees is not considered high with many being exotic. Their removal will re-establish the hospital's original views towards Mumbulla Mountain.

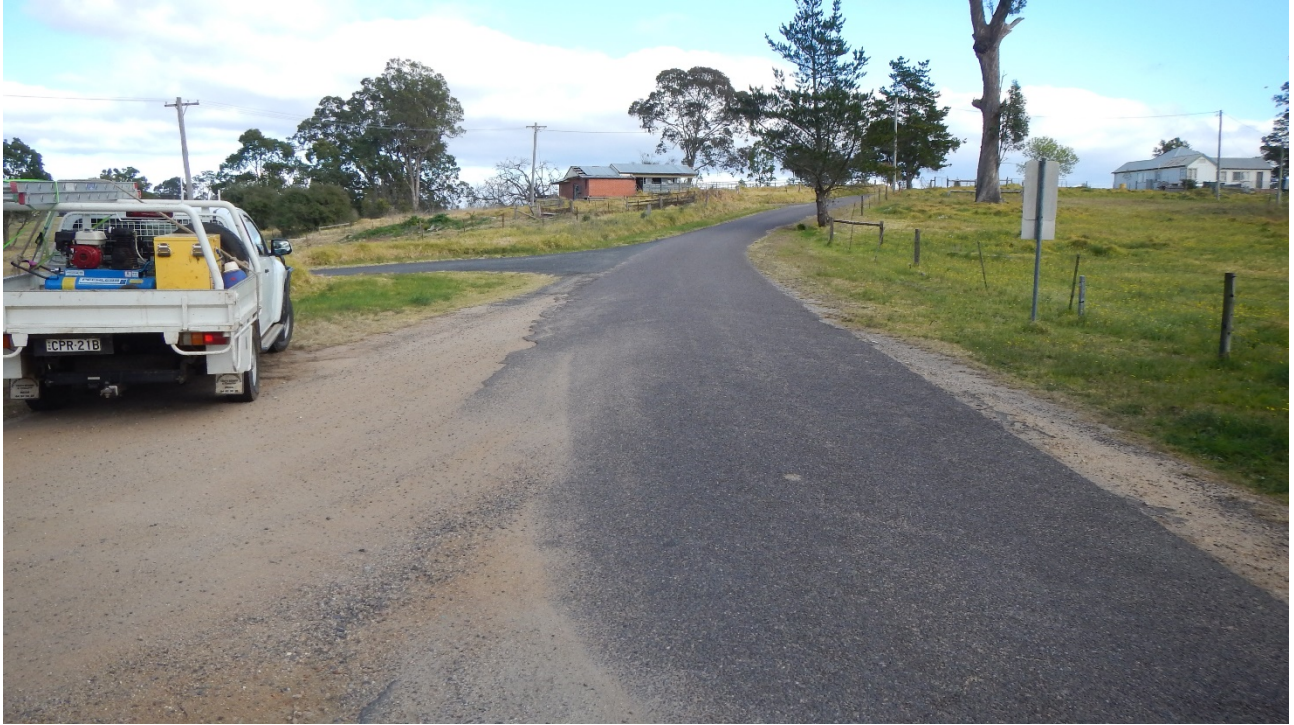
Figure 2 existing access road (Corkhill St) with 4 wide seal and passing shoulders

The access road exists and is considered adequate so long as the grass verges either side of the 4 metre wide seal are maintained to allow vehicles to pass. The current road was adequate for the development prior to the fire with no known serious accident history. Since that time the intersection with Newton Road has been improved including shoulder widening. There is now excellent sight distance.

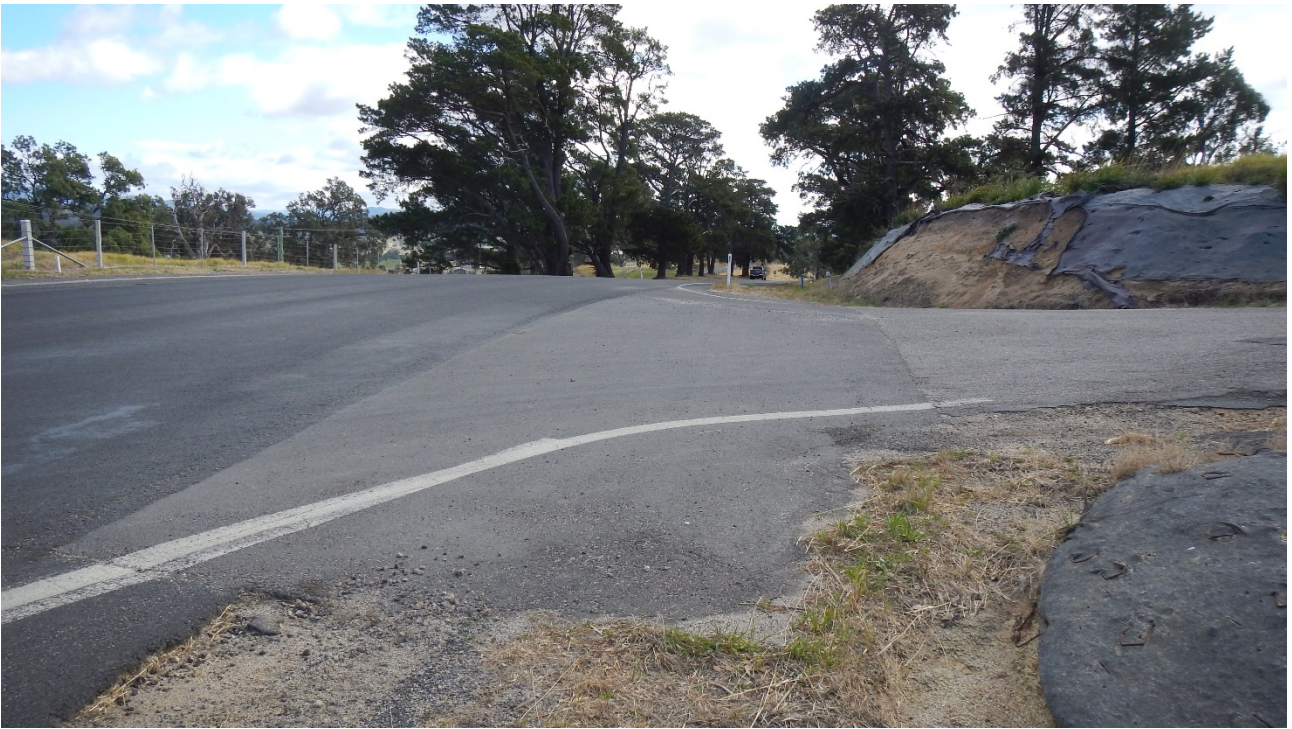
Figure 3 Corkhill intersection with Newton Road demonstrating in excess of 200 metres sight distance to the north

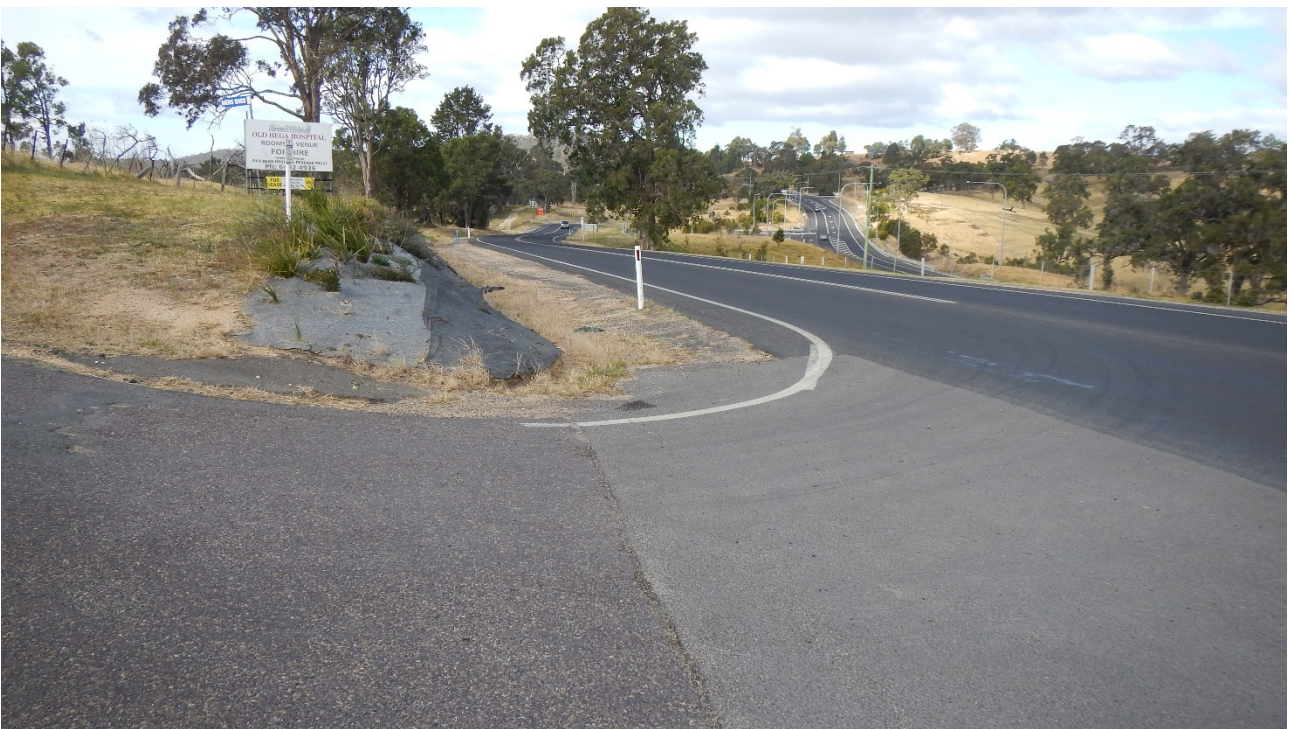
Figure 4 Intersection looking south with ample sight distance
