Job: Old Beza Hospital  
5th Beza

**SITE INSPECTION REPORT/INSTRUCTION.**

Chimney Support (at roof/ceiling) instruction.

Roof tie down detail.

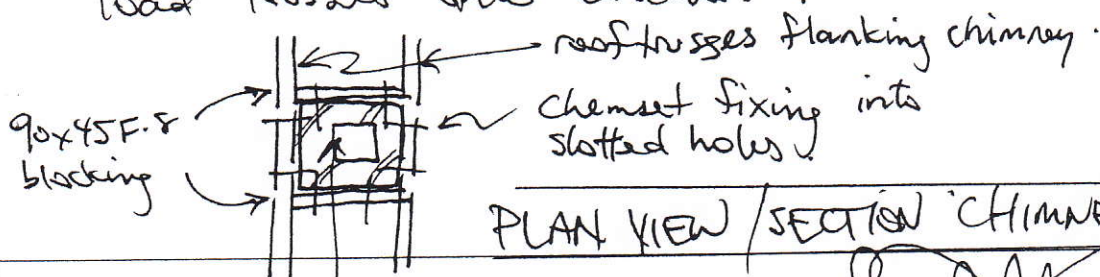
Chimney

All chimneys are to be flanked (i.e. fixed to) by 2 roof/ceiling trusses on parallel faces of chimney.

Perpendicular chimney faces are to be timber blocked with 90 x 45 F.F kd pine members to reach ceiling and roof chord of truss. i.e. fixed to AS1684 i.e. AS1720 requirements i.e. BCA. Roof i.e. ceiling battens locate here also.

Chimneys are to be fixed to truss top i.e. bottom chords and perpendicular blocking members with 2 equally spaced M10 chemset or epoxy set (to brickwork) anchors bolt fixed with nut i.e. washer through appropriate vertically slotted holes in truss chords to allow for truss vertical deflection up i.e. down so as not to load trusses onto anchors.

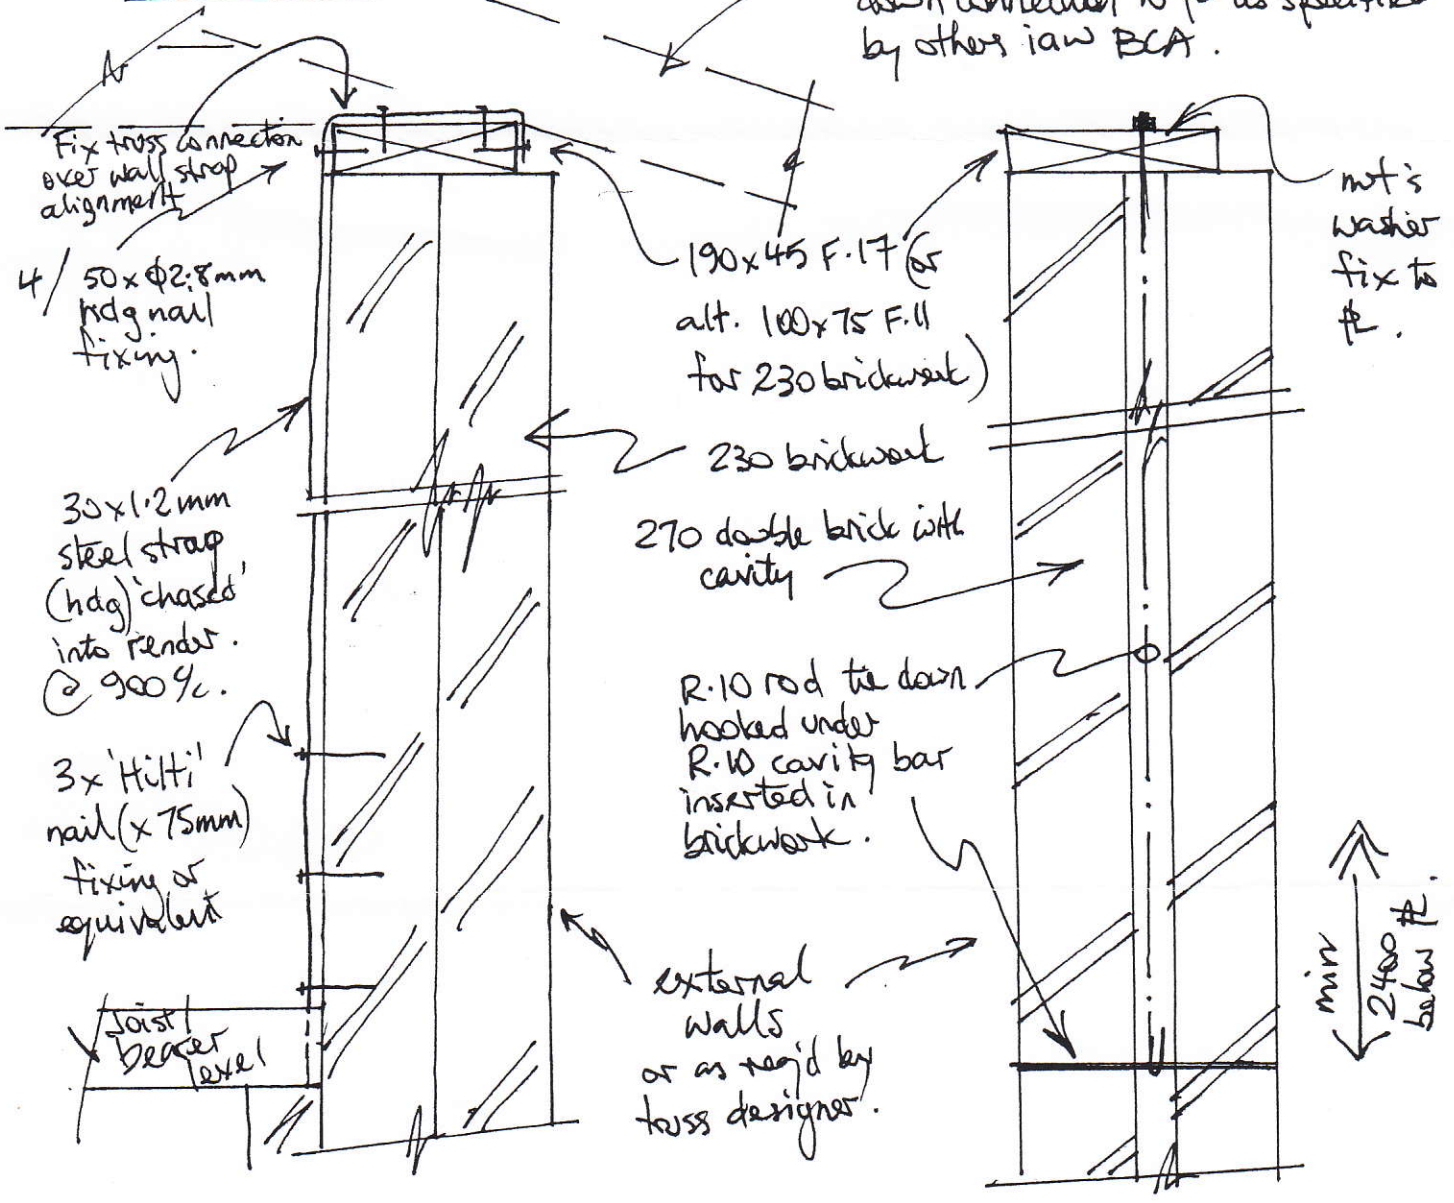
TYPICAL TOP  $\#$  TIE DOWN SECTIONS.

Pre fabricated timber roof truss tie down connection to  $\#$  as specified by other iaw BCA.
